Project/File: North Platte River Restoration Projects Date: June 1, 2022

Reference: Field Observations on the North Platte River Between Bryan Stock Trail and Knife River Property

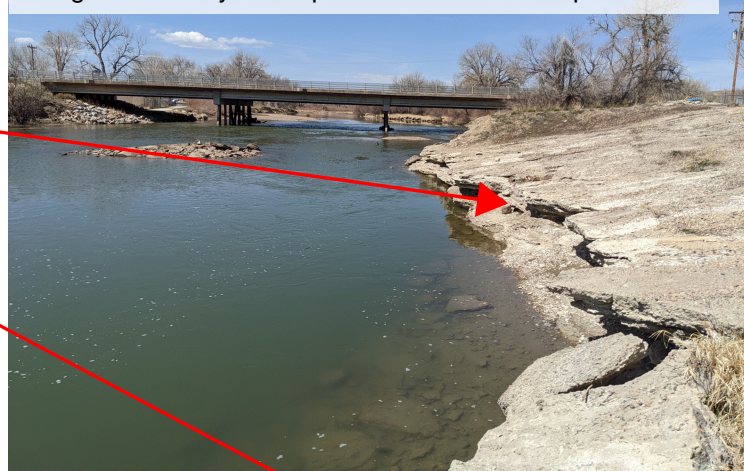
Photo 2: Layers of poured concrete along left bank

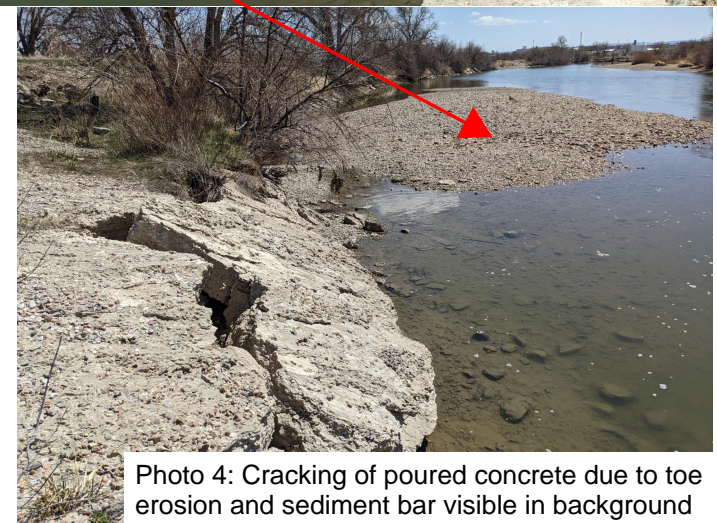
Photo 4: Cracking of poured concrete due to toe erosion and sediment bar visible in background

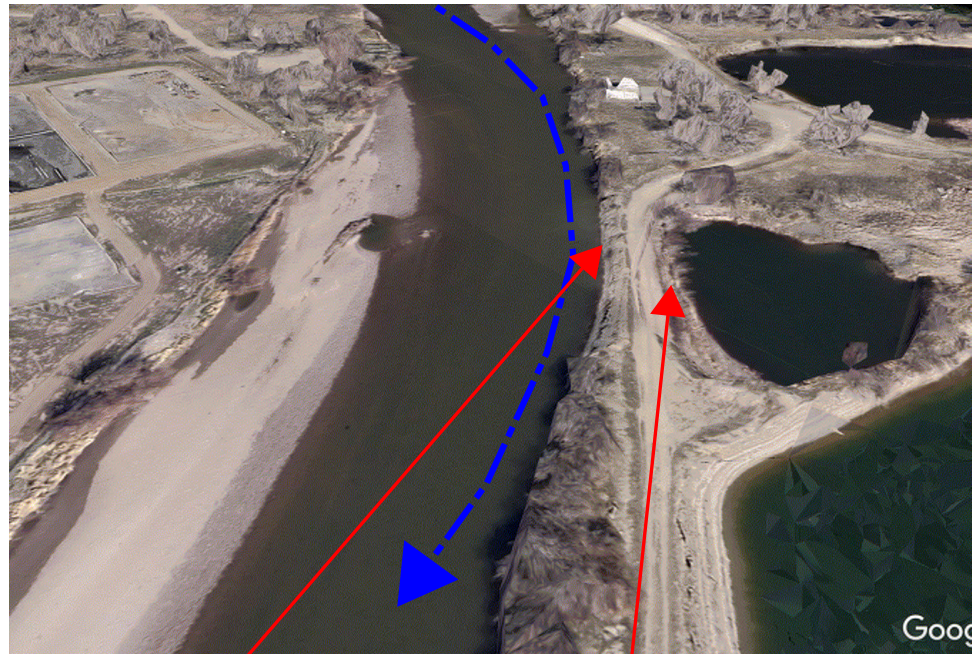
The bank angle is near vertical through much of this section with sparsely vegetated banks and is experiencing toe erosion and bank sloughing. The river is separated from a relic gravel pond by a narrow (12-15') strip of bermed bank for approximately 200 linear feet. This 200' section of bank, consisting primarily of unconsolidated small cobble/gravel/sand bank material, has lost all vegetation and exhibits signs lateral migration toward the pond. The pond side of the berm is also nearly vertical, sparsely vegetated with woody plants, and does not appear to be very robust. If the lateral retreat of this bank toward the pond is allowed to continue or if a large overtopping flow event were to occur, risk of a major channel avulsion through the gravel pond is likely. In this event, the river would likely abandon it's current course and flow through the gravel pond to the North-East, before returning back into the existing river channel (As shown in the Overview Map).

Photo 1: View east looking downstream of unstable river bank

The liability of this potential river avulsion needs to be a key consideration in any negotiations involving purchase of this land. The potential restoration of this area will require addressing this avulsion risk and also reworking the southern portion of the large gravel pond. As such, coordination with JTL Group, additional land acquisition, and/or securing of an easement will be critical to appropriately restore the river corridor and to mitigate potential risk of avulsion.

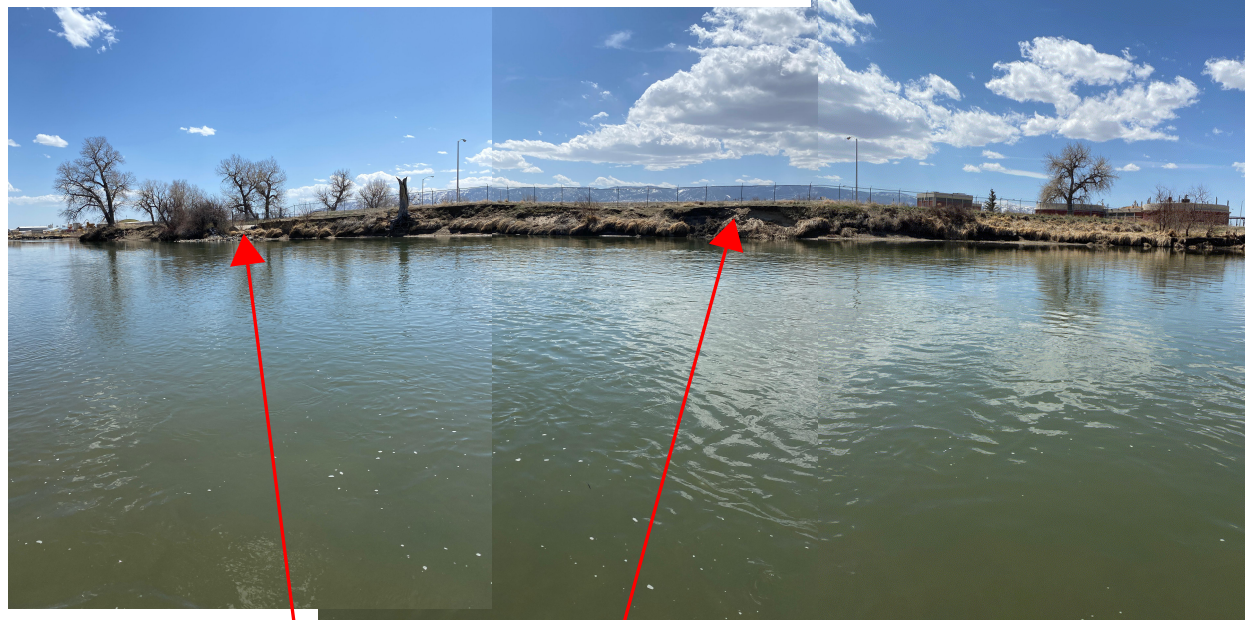
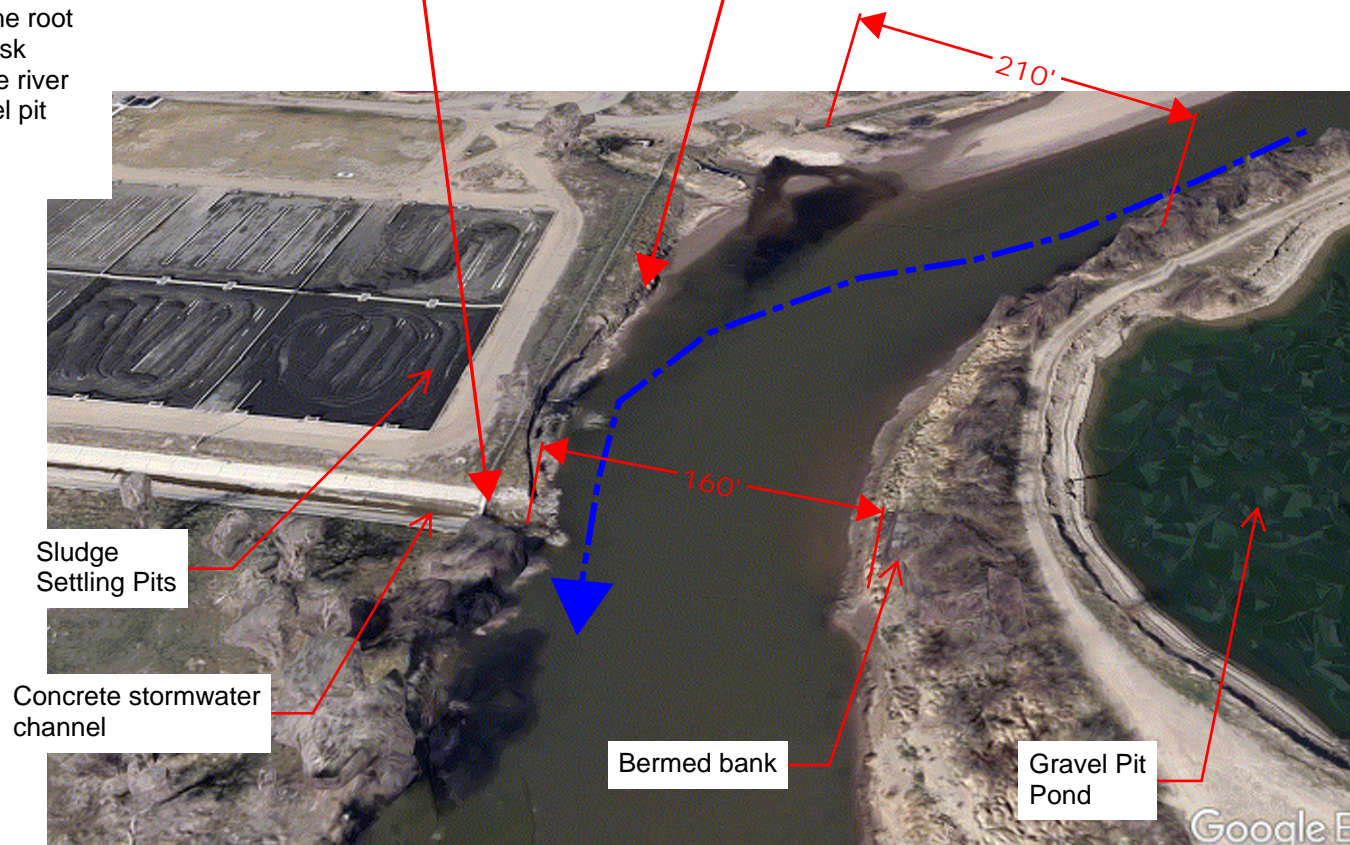
Problem Area 3 is located on the right descending bank, adjacent to the Sam H. Hobbs Regional Wastewater Facility, approximately 1,500 ft. downstream from the Bryan Stock Trail Bridge. The river thalweg shifts from the left to right side of the river along this reach and the wetted width reduces from approximately 200 ft. to approximately 160 ft. The reduction in width was created by the channelization and berming of the left bank for gravel mining operations. This constriction and high near bank stress along the right toe is causing toe erosion and mass wasting of the bank immediately adjacent to the Wastewater Facilities sludge settling pits.

There has been noticeable erosion and retreat of the bank apparent in the aerial imagery from the last 10-15 years, and it is currently threatening to undermine the facilities perimeter fence, which is only 30-40 from the edge of the sludge settling pit. Without intervention, incremental lateral retreat of this bank towards the wastewater facility is likely to continue. Additionally, a large flow event has the potential to cause major bank scouring and could threaten the integrity of the sludge pit, resulting in contamination to the river. Release of concentrated wastewater sludge into the river would result in detrimental affects to water quality, aquatic species, and impact downstream drinking water sources.

Photo 1: View south looking across the river at the unstable river bank adjacent to the Sam H. Hobbs Regional Wastewater Facility

While temporary stabilization of this bank would help to reduce the short-term erosion risk to the wastewater facility, addressing the root cause of the instability is recommended to provide long term risk mitigation. Addressing the root cause would require shifting the river away from the facility towards the north by modifying the gravel pit pond and improving floodplain connectivity.

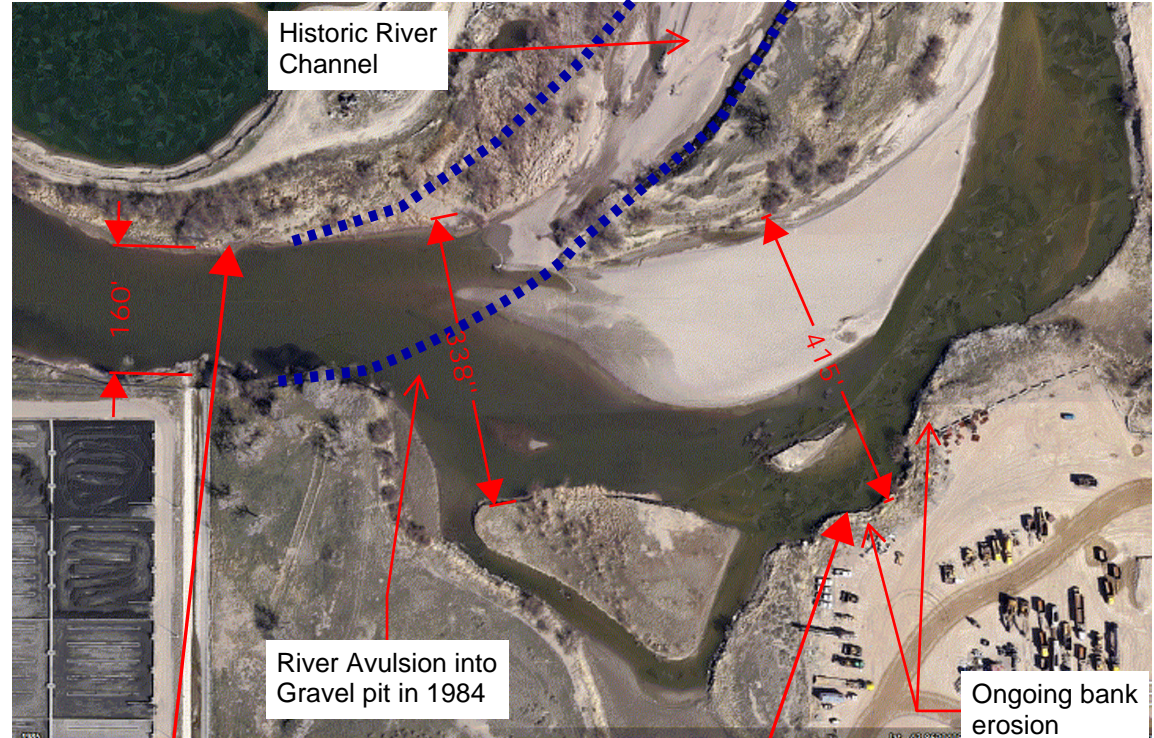
Contrary to the claim in the permit, this river reach is very unstable and exhibits both large areas of sediment deposition and bed/bank erosion, as shown in the historic aerial images shown on next page. The extreme expansion and over-widened river cross section drastically reduces the river's ability to transport sediment, leading to the formation of large sediment bars consisting of fine-grained material. Overwide channels have very poor aquatic habitat and shallow water is prone to temperature increases due to solar radiation. In addition, the tight, dogleg turn to the north has experienced bank erosion, requiring extensive bank armoring, which currently consists of wasted concrete slabs. This problematic bank erosion has been observed and documented along the right descending bank, potentially threatening the JTL Group, Inc. property and Shop. The entirety of the right bank through this reach has been armored with wasted concrete slabs in an attempt to stabilize the bank but provide little/no potential for vegetation establishment.

Photo 1: View east looking downstream at the overwide river channel at point of 1984 avulsion.

Due to the extensive volume of river alluvium mined from the current North Platte River Channel and a history of river avulsion, successful restoration and mitigation of further avulsion risk in this area will require a holistic approach in order to be successful. This will involve the reworking of the north river bank and southern portion of the adjacent gravel pit pond, in order to improve floodplain access, reduce erosion risk to the wastewater treatment facility, and creation of a robust outer right bank with a reduced radius of curvature required to relocate the river back to the relic channel. The current river channel can be converted into a series of oxbow lakes and wetland systems designed to treat stormwater from south of the site. Because so much of this corridor has been mined, imported alluvium will likely be required to properly reestablish channel banks and floodplains. Locations and configuration of the oxbow lakes will have to be optimized to account for net fill needed to balance the site.
