2018 Annual Monitoring Report for the North Platte River Restoration Project

Joanna Harter, Aquatic Habitat Project Biologist

Wyoming Game and Fish Department, 5400 Bishop Blvd, Cheyenne, WY 82006

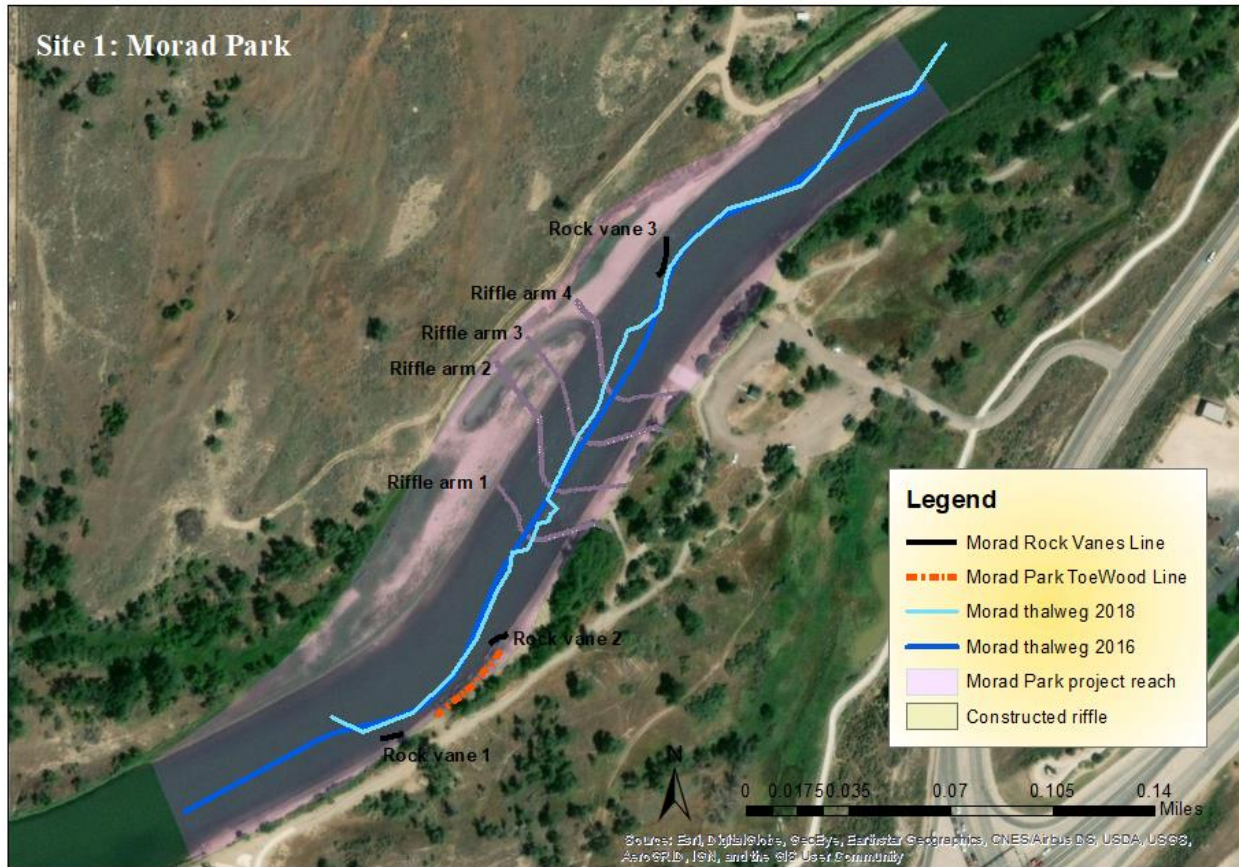
Figure 4. - Location of in-stream structures in 2018 and the thalweg lines from 2016 and 2018.

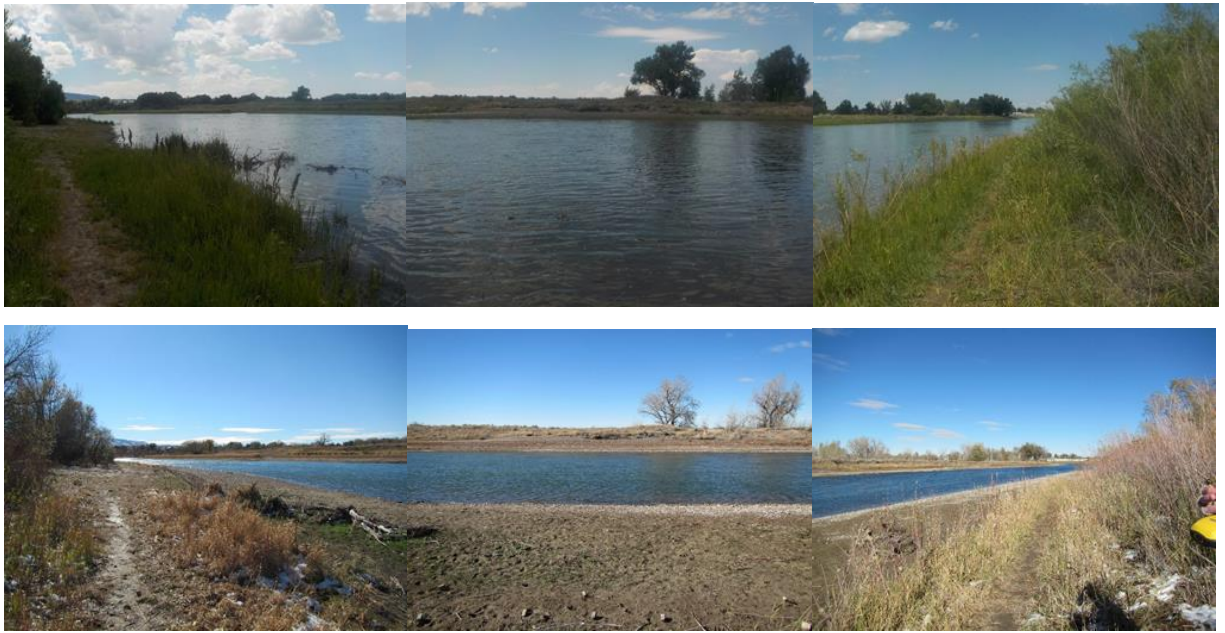
Figure A.2.5. Views from photo point MP-4 looking upstream (left), across (middle), and downstream (right). Vandalism in 2016 also resulted in loss of most stakes along this bank. Most of the vegetation establishment has been herbaceous, although many young willows have established downstream.

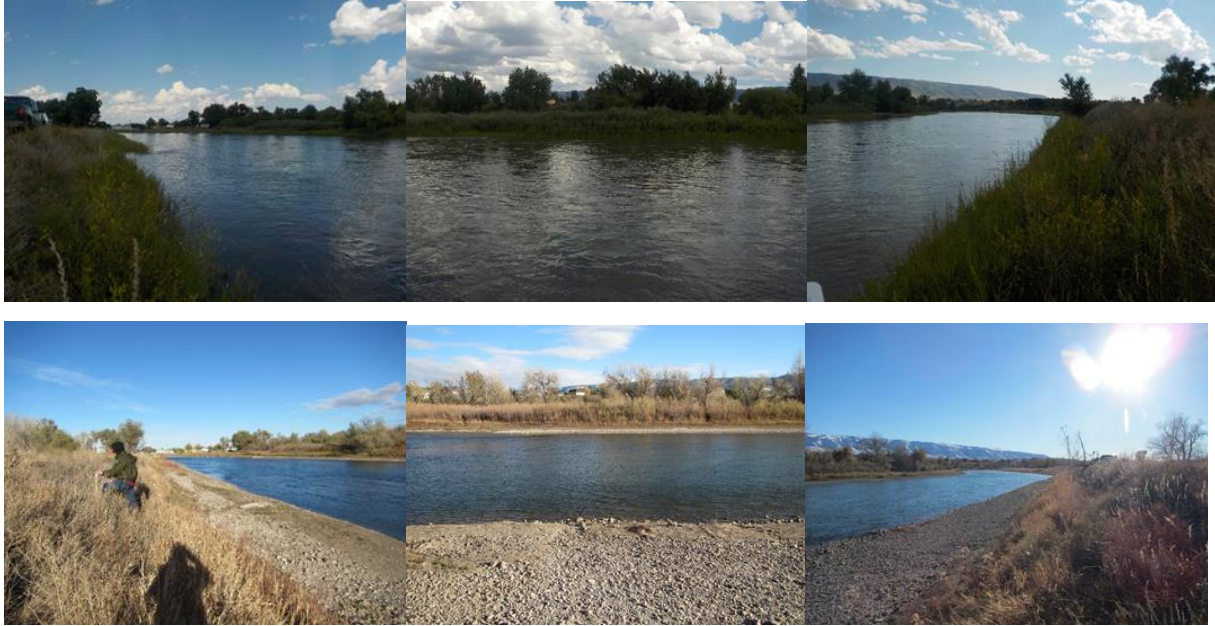
with the boat ramp, trails, and the dog park. The left bank receives little human disturbance and most of the observed vegetation was herbaceous. Willow and cottonwood stakes did not survive in some areas along the reconstructed bank. Although streamflow is directed more toward the right banks through this site, long-term bank stability of the left bank may be at risk in some places as the core fabric deteriorates and if woody vegetation establishment does not increase.

Figure A.2.6. Views from photo point MP-5 looking downstream (left), across (middle), and upstream (right). Almost all of the vegetation growth along this left bank is herbaceous. Even though vandalism didn't affect the planted stakes in 2016 here, many of the stakes did not survive.

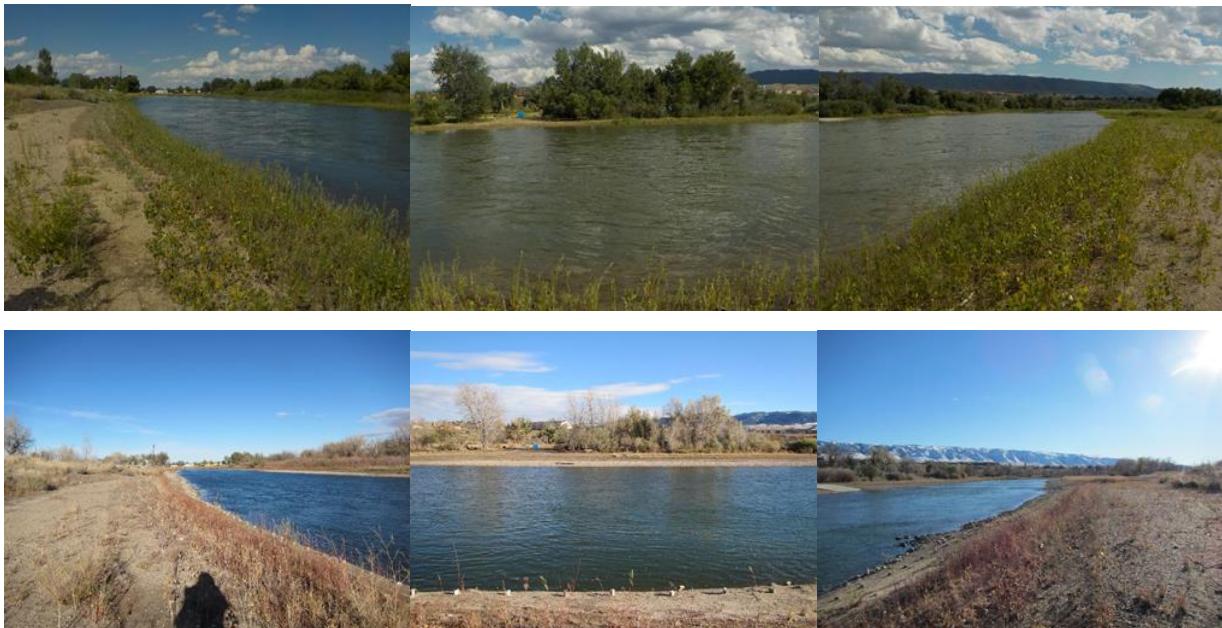
Figure A.2.7. Views from photo point MP-6 looking downstream (left), across (middle), and upstream (right). Many cottonwoods and willows are established and doing well both upstream and downstream. However, the top of these banks are still mostly bare. The upstream image shows the constructed riffle vanes, which continue to function to control the grade and direct flow to the center of the channel.

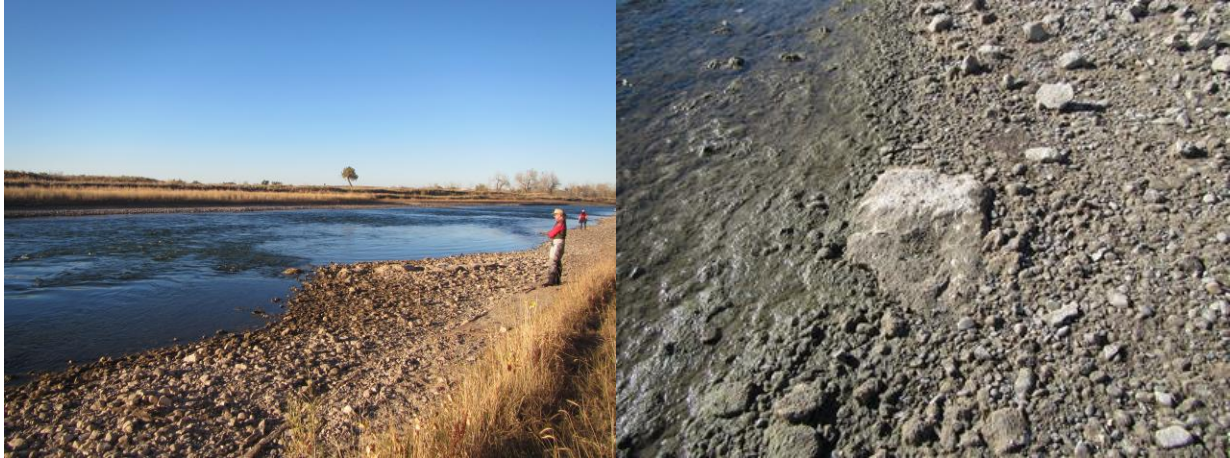
riffle arms seemed to have at least some deposition over them, but deposition was greater on the two downstream arms. Riffle arms 1 and 2 received an erosion/deposition rating of “1 (minor deposition)” while riffle arms 3 and 4 received a rating of “2 (deposition along 25-50% of structure)”. The differences in elevation between the top of the riffle arms and the bottom of the scour pools below them are much greater in 2018 than in 2016 (Figure A.1.1). In 2016, the differences were all approximately 1 ft. In 2018, survey data showed differences of 4.57 ft, 2.43 ft, and 1.94 ft for riffle arms 1, 2, and 3, respectively (Figure A.1.1). The depths of pools between riffles arms will likely vary year to year. As a whole, the constructed riffle seems to continue to function as grade control, directs stream flow to the center of the channel to maintain narrow channel dimensions, and maintains pools for fish habitat.

Figure A.3.1. Site 1 - Morad Park, standing on the left bank, looking downstream at the constructed riffle (left) on 10/15/2018. Arm 1 of the constructed riffle is in the foreground, with multiple boulders visible out of water on the right bank. Turbulence from arms 2 and 3 can be seen downstream in background. On the left is one of the only visible boulders in the fourth (most downstream) arm of the constructed riffle.

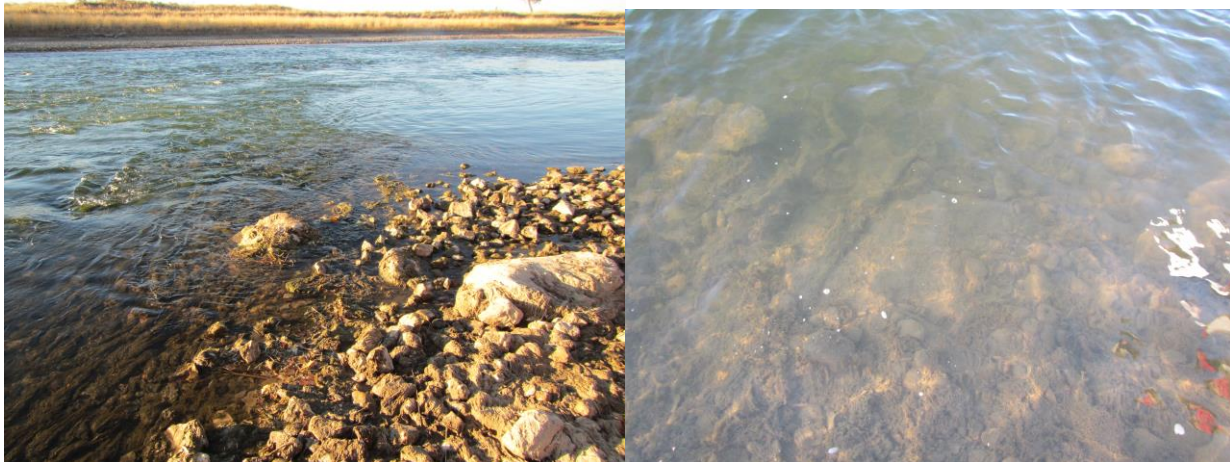
The three rock vanes remain in their appropriate locations according to design plans. Sorted cobble-sized substrate was deposited downstream of the underwater portion of each rock vane, making them seem almost buried, as intended. Scour pools are well-defined on the downstream side of each rock vane. The main intent of the rock vanes is to direct flows away from the bank toe and toward the center of the channel. Rock vane 1 functions to protect the toe wood immediately downstream from scour. The intended function of rock vane 2 was to help transition out of a pool and into a riffle. According to the design engineer, a rock vane in this location may experience high aggradation and the structure may not have been essential at this location. Rock vane 3 was constructed at the upstream end of a pool and was intended to protect the left bank as the river bends to the right and to direct flows from the side channel back toward the center. All three rock vanes received a rapid assessment procedure structural integrity rating of “Intact” (Table A.4.1). Rock vanes 1 and 2 received an erosion/deposition rating of “1”, because of minor deposition over the center of the structure and a well-defined pool being maintained. Rock vane 3 received an erosion/deposition rating of “2” because of more significant deposition along 25-50% of the structure that is affecting the intended function of the structure. An eddy, about 50 feet long, was observed just downstream of rock vane 3. It likely formed due to excessive deposition associated with the rock vane and may cause higher near-bank stress on the left bank. Rock vane 3 was difficult to rank for structural integrity using the rapid assessment descriptions because the structure is intact but it is likely not functioning as intended. There is no ranking that accounts for that condition.

Figure A.3.2. Site 1 - Morad Park, standing on right bank, looking across the channel at Rock vane 1 (left). The header boulders are visible above base flow in the foreground (left). Boulders underwater at the same level of the surrounding substrate further into the channel (right).

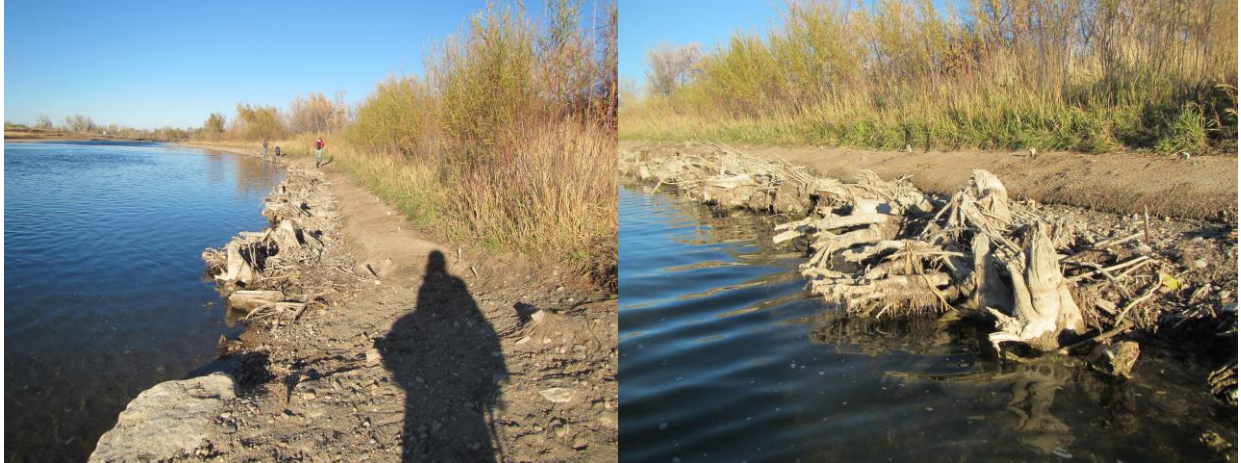
The toe wood structure is still intact and functions to protect the outer bank and to provide cover and habitat for fish. The root wads were installed a little higher than preferred, according to the design engineer. Ideally, the root wads would be submerged during base flow, but the upper half of the root wads is exposed during base flow. Rootwads were installed with slightly wider spacing toward the downstream end of the toe-wood structure; this is not indicative of missing root wads. The toe wood received an “Intact” rating for structural integrity and a “0 (none visible)” for erosion/deposition.

Figure A.3.3. Site 1 - Morad Park, standing on right bank, looking downstream at toe wood.
