2016 Annual Monitoring Report for the North Platte River Restoration Project

Mike Robertson, Instream Flow Biologist, Wyoming Game and Fish Department, 5400 Bishop Blvd, Cheyenne, WY 82006

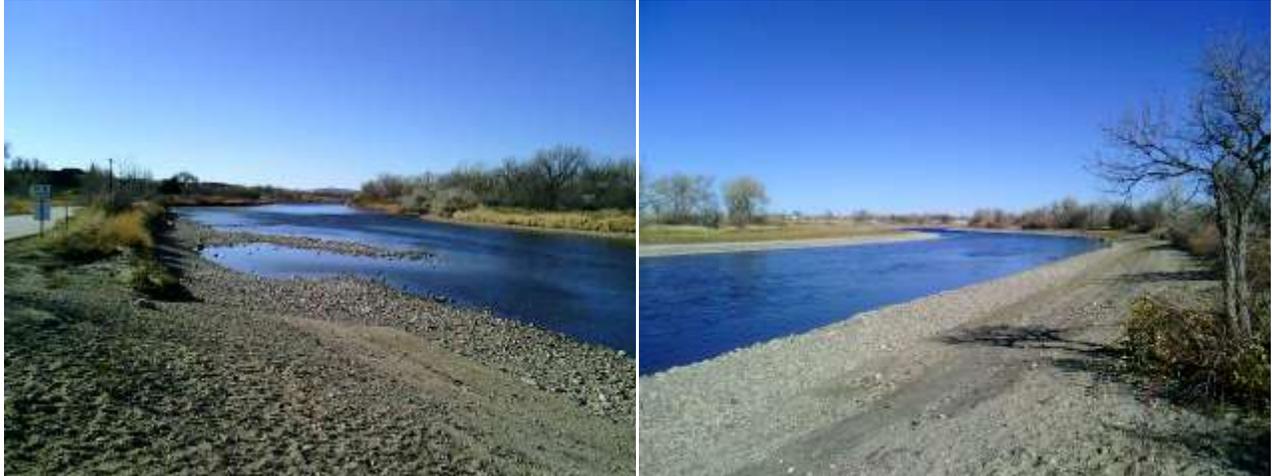
Figure A2. Upstream (left) and downstream (right) view from photo point 1 taken on November 4, 2016. Looking upstream, the image shows some deposition of sediment along the near shore and creation of a cobble/gravel bar. This portion of the river is just upstream of the project site. Vandalism affected vegetation plantings all along this bank.

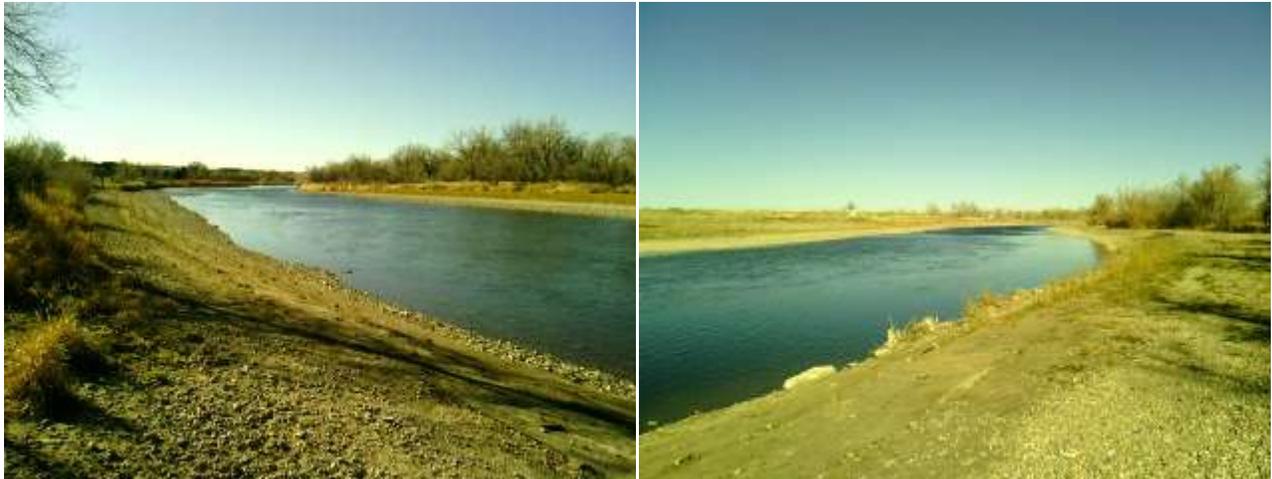
Figure A3 Upstream (left) and downstream (right) view from photo point 2 taken on November 4, 2016. The lack of vegetation is clear on the upstream photo, but looking downstream, there is some willow growth along the toe-wood structure evident in the center of the photo. There is a rock vane arm in the foreground of the downstream-facing image and another in the far-ground of the same image. It's not clear in these photos, but during the field assessment, the current was observed to be re-directed back in toward the center of the channel, away from the near bank.

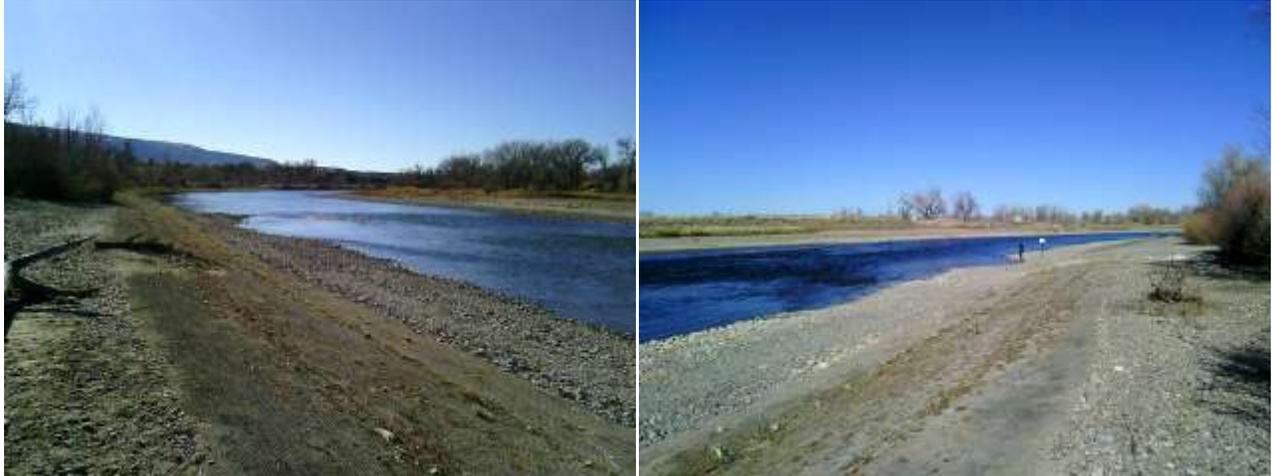
Figure A4. Upstream (left) and downstream (right) view from photo point 3 taken on November 4, 2016. Very little vegetation is evident along this portion of the bank as this is the most accessible area from the parking lot and all live stakes were removed. The turbulence in these two images correspond to the constructed riffle arms; each created a distinct riffle feature that appears to be holding the grade of the stream bed as intended.

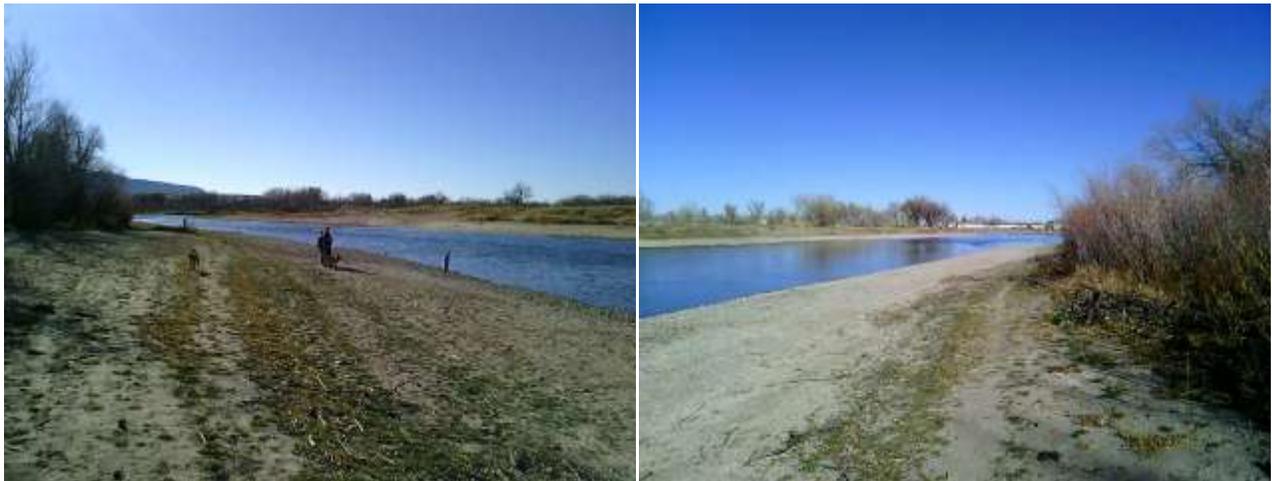
Figure A5. Upstream (left) and downstream (right) view from photo point 4 taken on November 4, 2016. A few live stakes remained in this section, but like the other sections of this bank, most have been removed and it will be difficult to establish any vegetation along this bank.

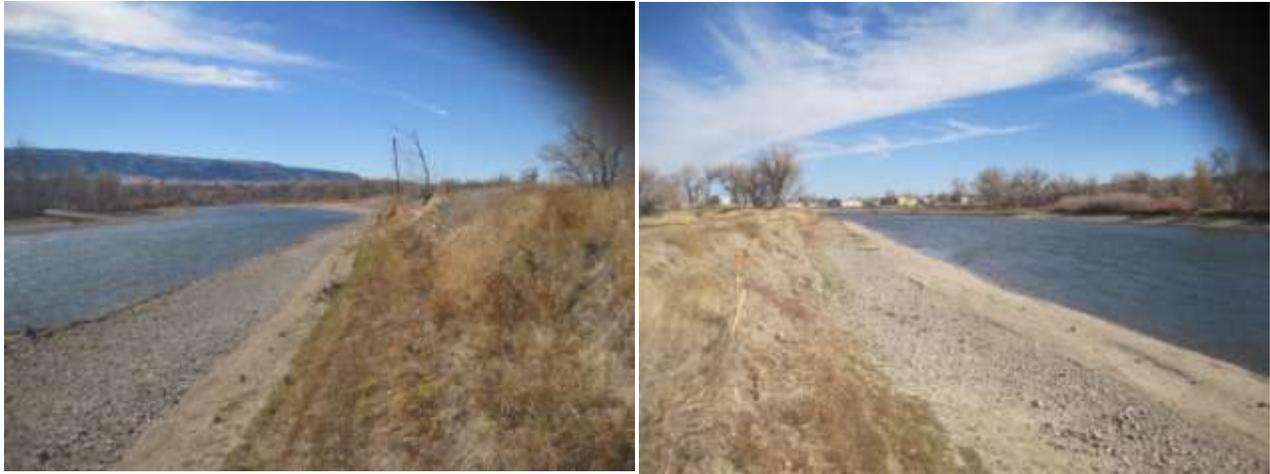
Figure A6. Upstream (left) and downstream (right) view from photo point 5 taken on November 2, 2016. On this side of the river, live stakes remain (it's inaccessible to the public), but most did not appear to fare well. Some seem to be alive and growing small leaves, but growth is slow and may take a while to establish.

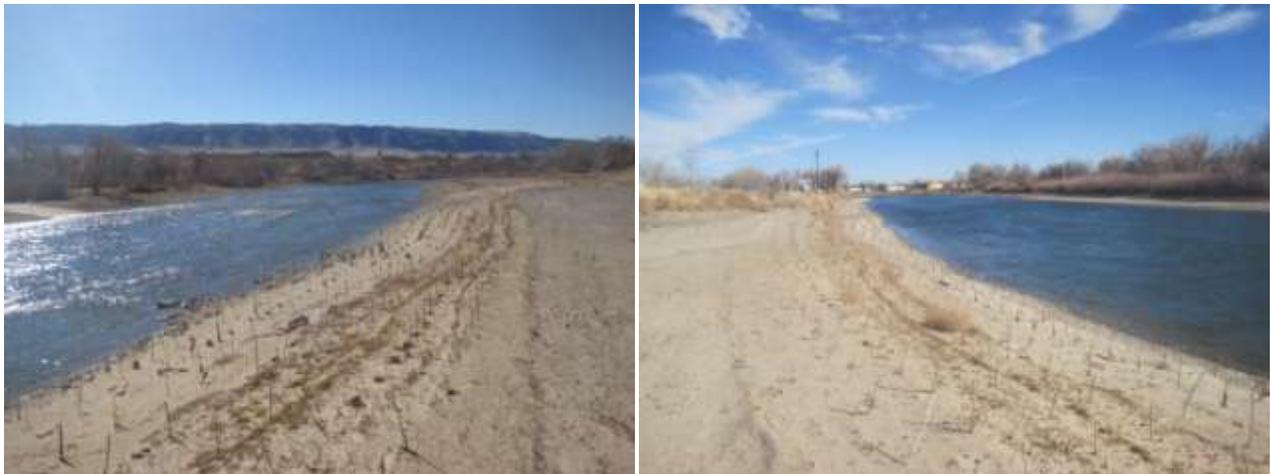
Figure A7. Upstream (left) and downstream (right) view from photo point 6 taken on November 2, 2016. Many more live stakes are evident in these photos. It is difficult to assess survival and growth from these photos. The upstream image does include the constructed riffle vanes, but it is not easy to see these from this vantage point. In the foreground of the upstream image is the downstream-most rock arm located where the large boulder is visible. This vantage point does not allow a very good evaluation of its integrity, but a close visual inspection in the field showed that the current was being re-directed away from the bank and toward the center of the channel.

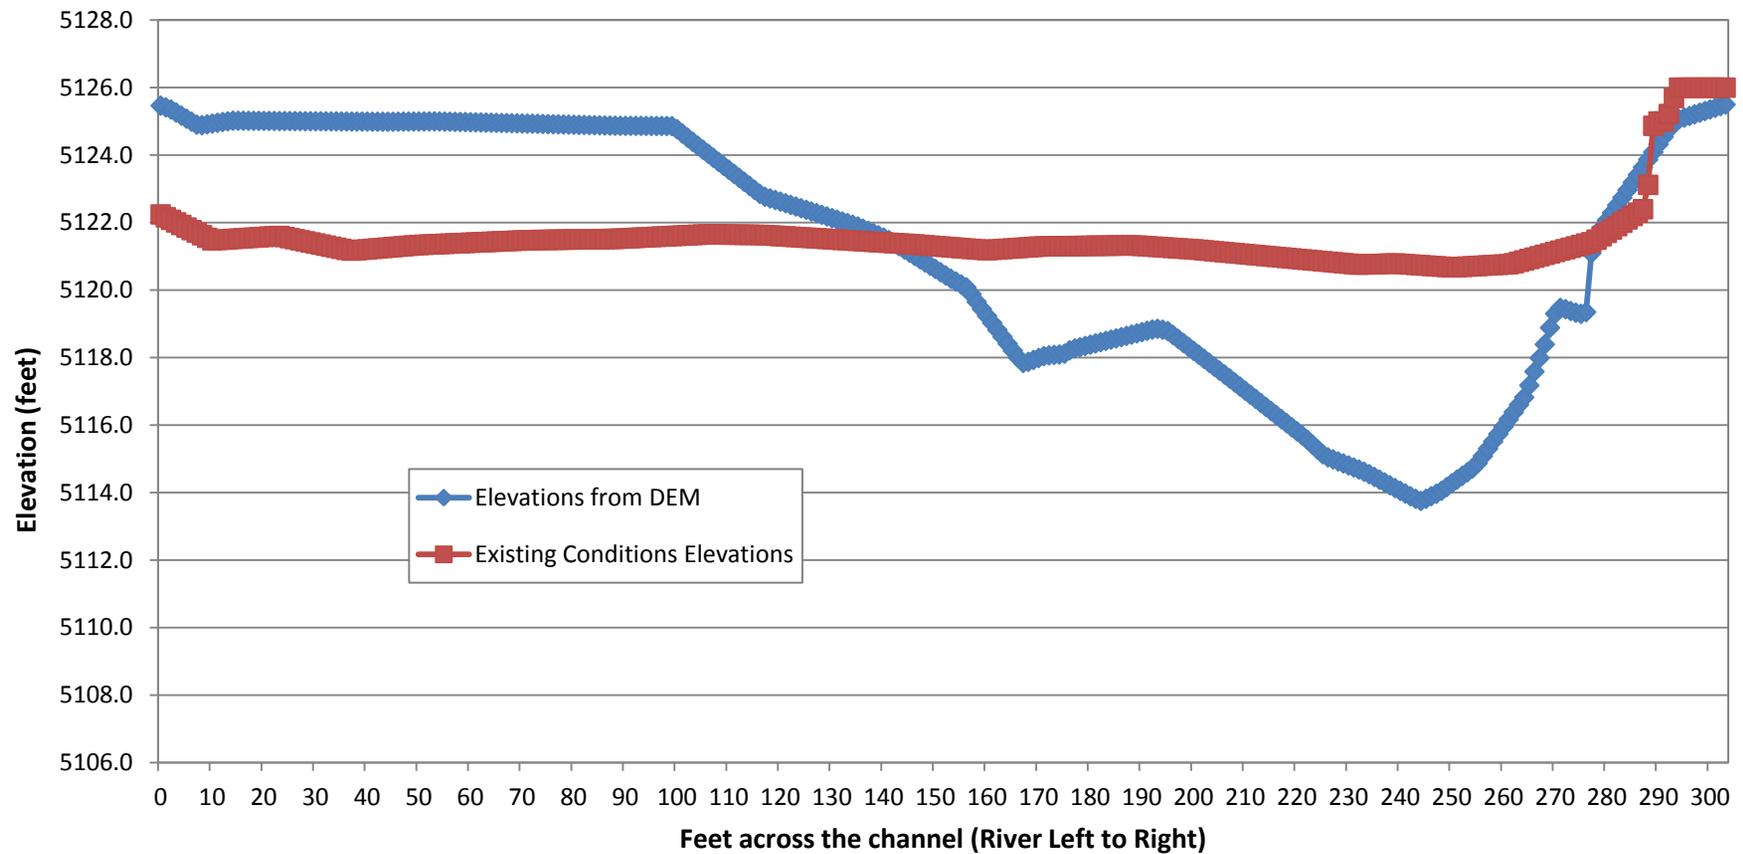
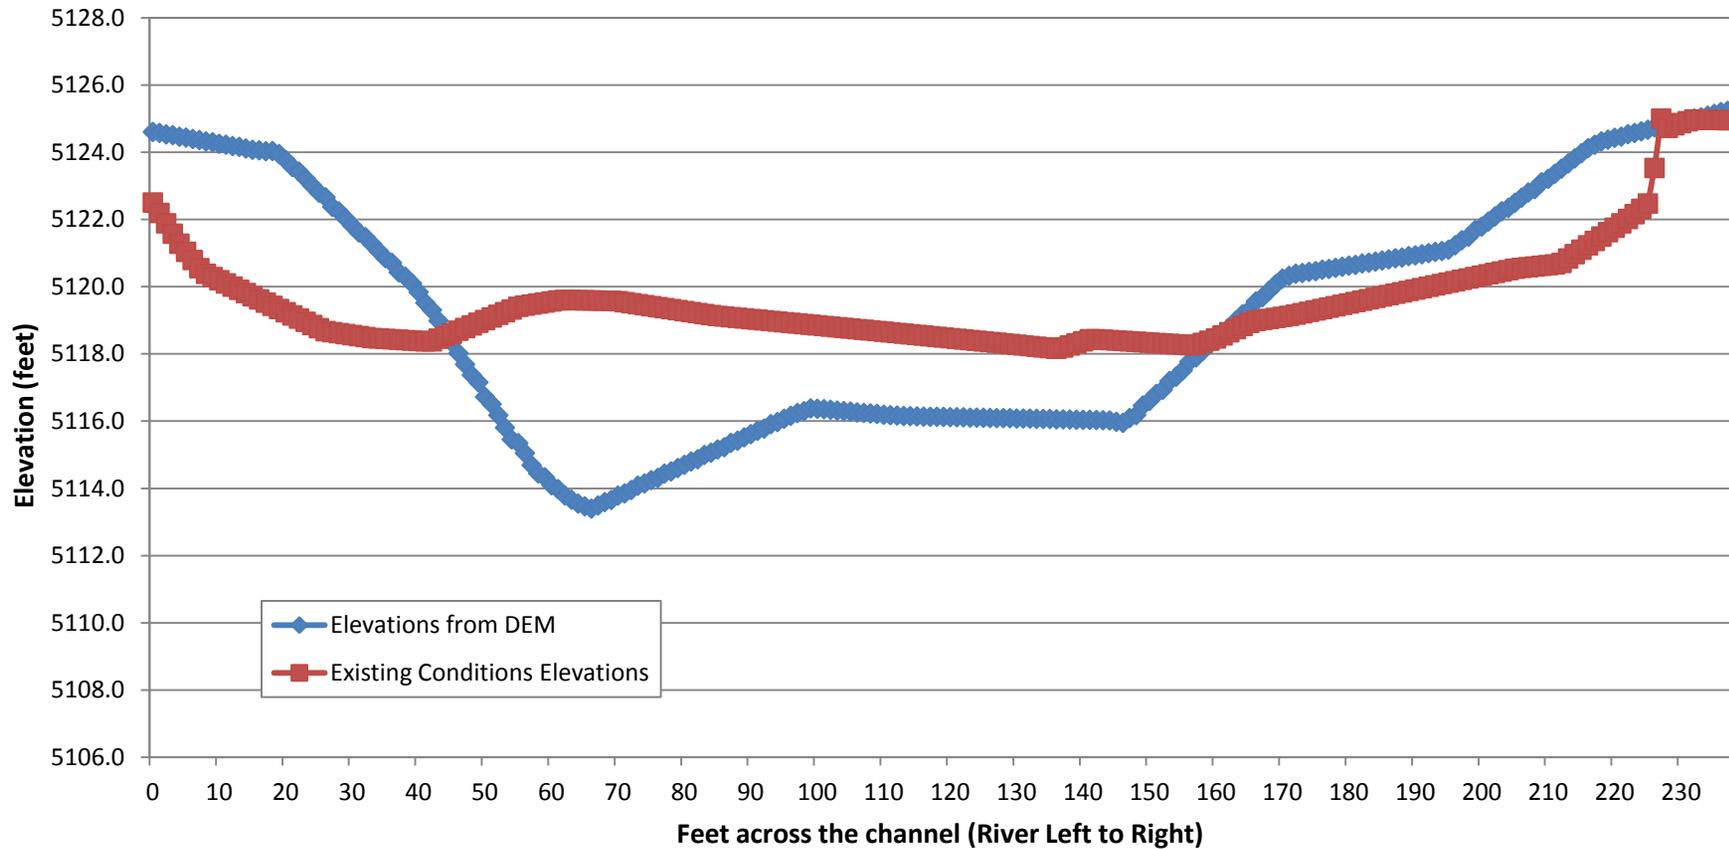
The topographic survey data indicate that the two deep pools excavated during construction were approximately 11.1 (upstream pool) and 10.6 (downstream pool) feet deep. These values are greater than the pre-construction maximum pool depth of about 8.5 feet but not as deep as the project design (about 12.2 feet each) (Appendix B, Figures B2 and B4). The observed depths represent approximately 90% and 87% of the project design depths.

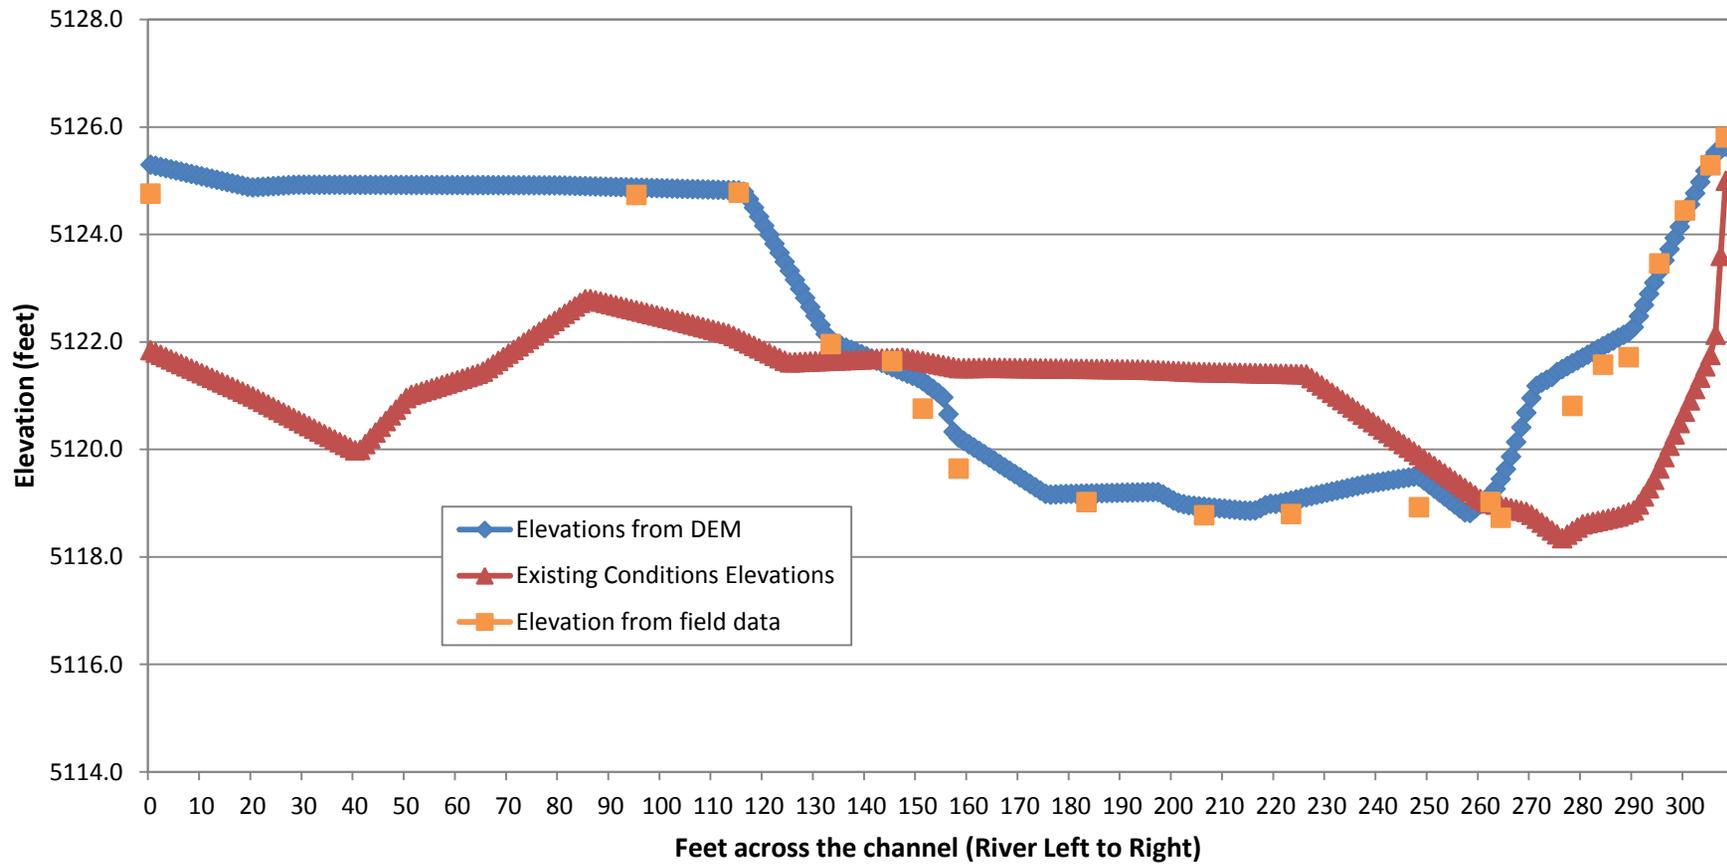
Cross-sectional area varied between approximately 1300 and 1460 square feet in the Morad Park site before construction and was reduced to an average of 873 square feet in the two riffle cross-sections (808 and 937 square feet respectively) after the channel was re-shaped (Appendix B, Figures B3 and B5), which is close to the 950 square feet design plan.

Figure B3. Profile of cross-section 2 (riffle) collected in October 2016. In addition to field data collected by WGFD, data were extracted from the pre-existing conditions and digital elevation model (DEM) of the final as-built topographic survey maps of the river bed.

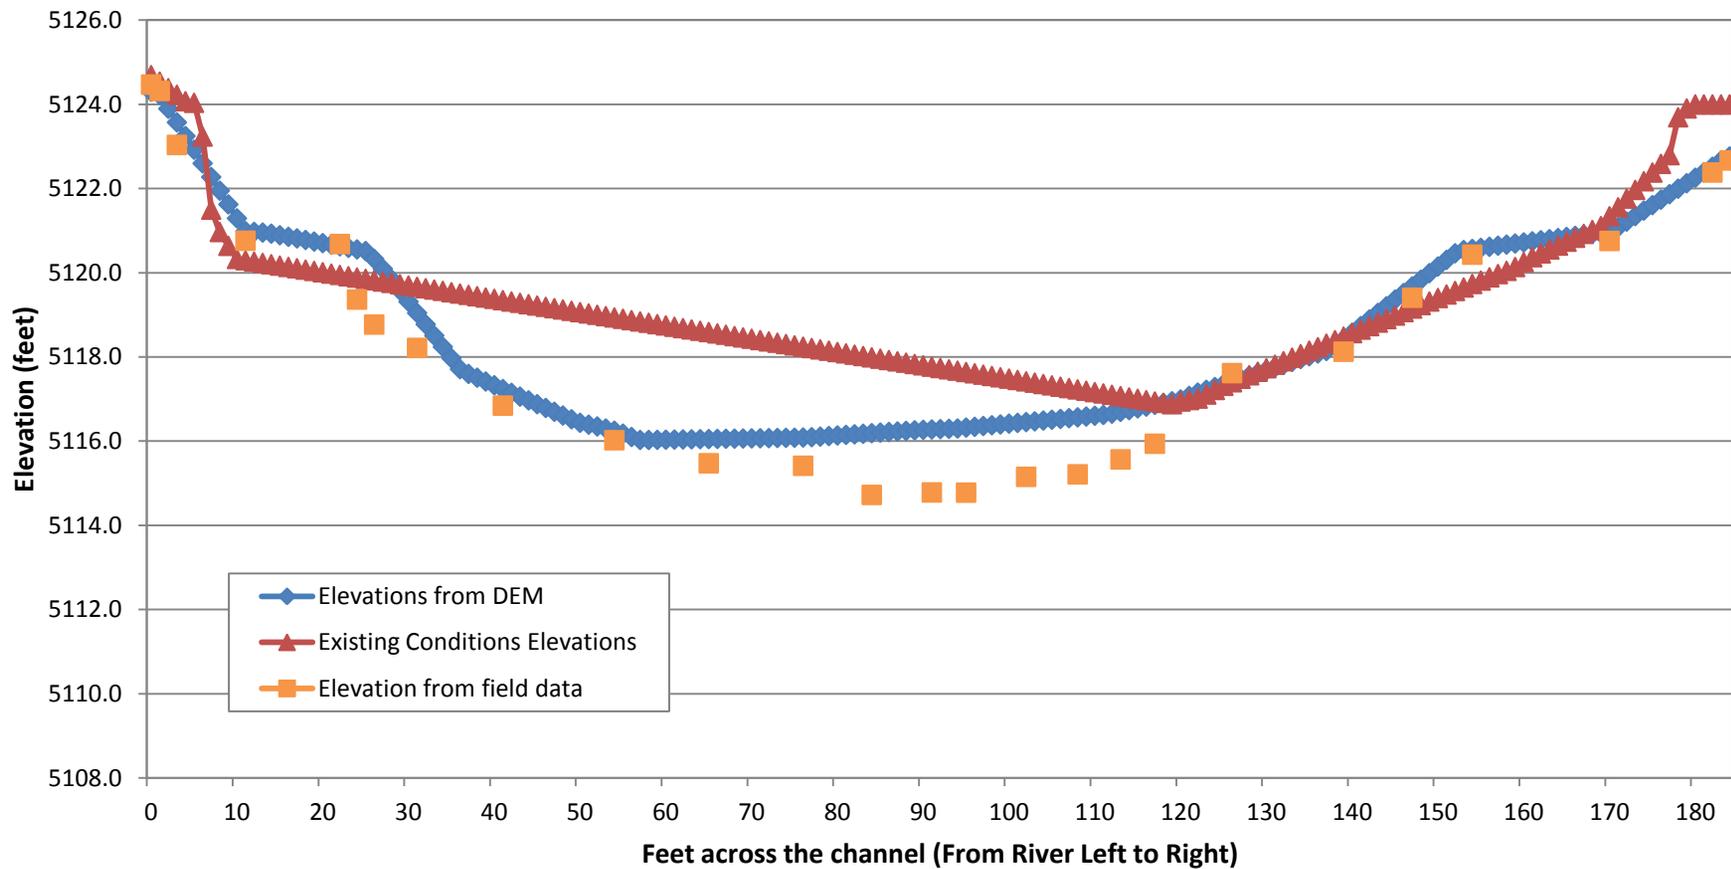
The width-to-depth ratio of the reconstructed channel was 31.6 in the constructed riffle and 23.2 in the downstream riffle; the goal was 35 to 48. One concern with these data is that the downstream riffle was much deeper than expected when the data were collected. The width-to-depth calculation is strongly impacted by selection of an appropriate riffle and the downstream cross-section used for monitoring in 2016 does not provide the appropriate conditions for this calculation. Therefore, only the results of the cross-section over the constructed riffle will be considered for the width-to-depth calculation this year.

Also related to the first goal of narrowing the channel, both the width to depth ratio and cross-sectional area values were improved to within the planned range. Unfortunately, field efforts resulted in collecting data at a cross-section that was designated riffle, but too deep to be representative of that feature type. Some effort to relocate the cross-section in the field to a shallower spot was not successful (data were collected in a spot that was ultimately downstream of the project reach and not considered). This resulted in a width-to-depth value that was outside of the desired range for this deeper cross-section, but the better riffle cross-section yielded a ratio of 31.6. The desired range was 35 to 48 and pre-construction values ranged from 52 to 100 so the improvement was notable. This was one of the most significant geomorphic changes (and clearly visible in before and after photos that show the change in channel width) associated with the restoration efforts that results in a channel that is able to pass sediment more effectively and to reduce the likelihood of accumulating sediments in the middle of the channel. The new cross-sectional area of 873 square feet was also close to the design value of 950 square feet. Future monitoring efforts will enable an evaluation of whether this value remains stable and varies by less than 10% in this project site, as desired, or within the 15% variation among all sites.

Figure B5. Profile of cross-section 4 (riffle) collected in October 2016. Field data collected by WGFD were deeper in the center of the channel than the topographic survey results of the river bed. In addition, data were extracted from the pre-existing conditions and digital elevation model (DEM) of the final as-built topographic survey maps of the river bed.

The first year of monitoring the Platte River restoration project indicated that the project met nearly all goals. However future monitoring will help determine the success of riparian vegetation reestablishment. Monitoring efforts should be continued for the full five year window for Site 1 – Morad Park as described in the monitoring plan (WGFD 2017) and monitoring efforts should be initiated the first year after each new site is constructed. No additional monitoring is needed on cross-section 4 because it is technically not a riffle.
