**PLATTE RIVER REVIVAL RESTORATION MONITORING
CITY OF CASPER
CASPER, WY**

December 21, 2016

Revised February 13, 2017

SUBMITTED BY: Trihydro Corporation

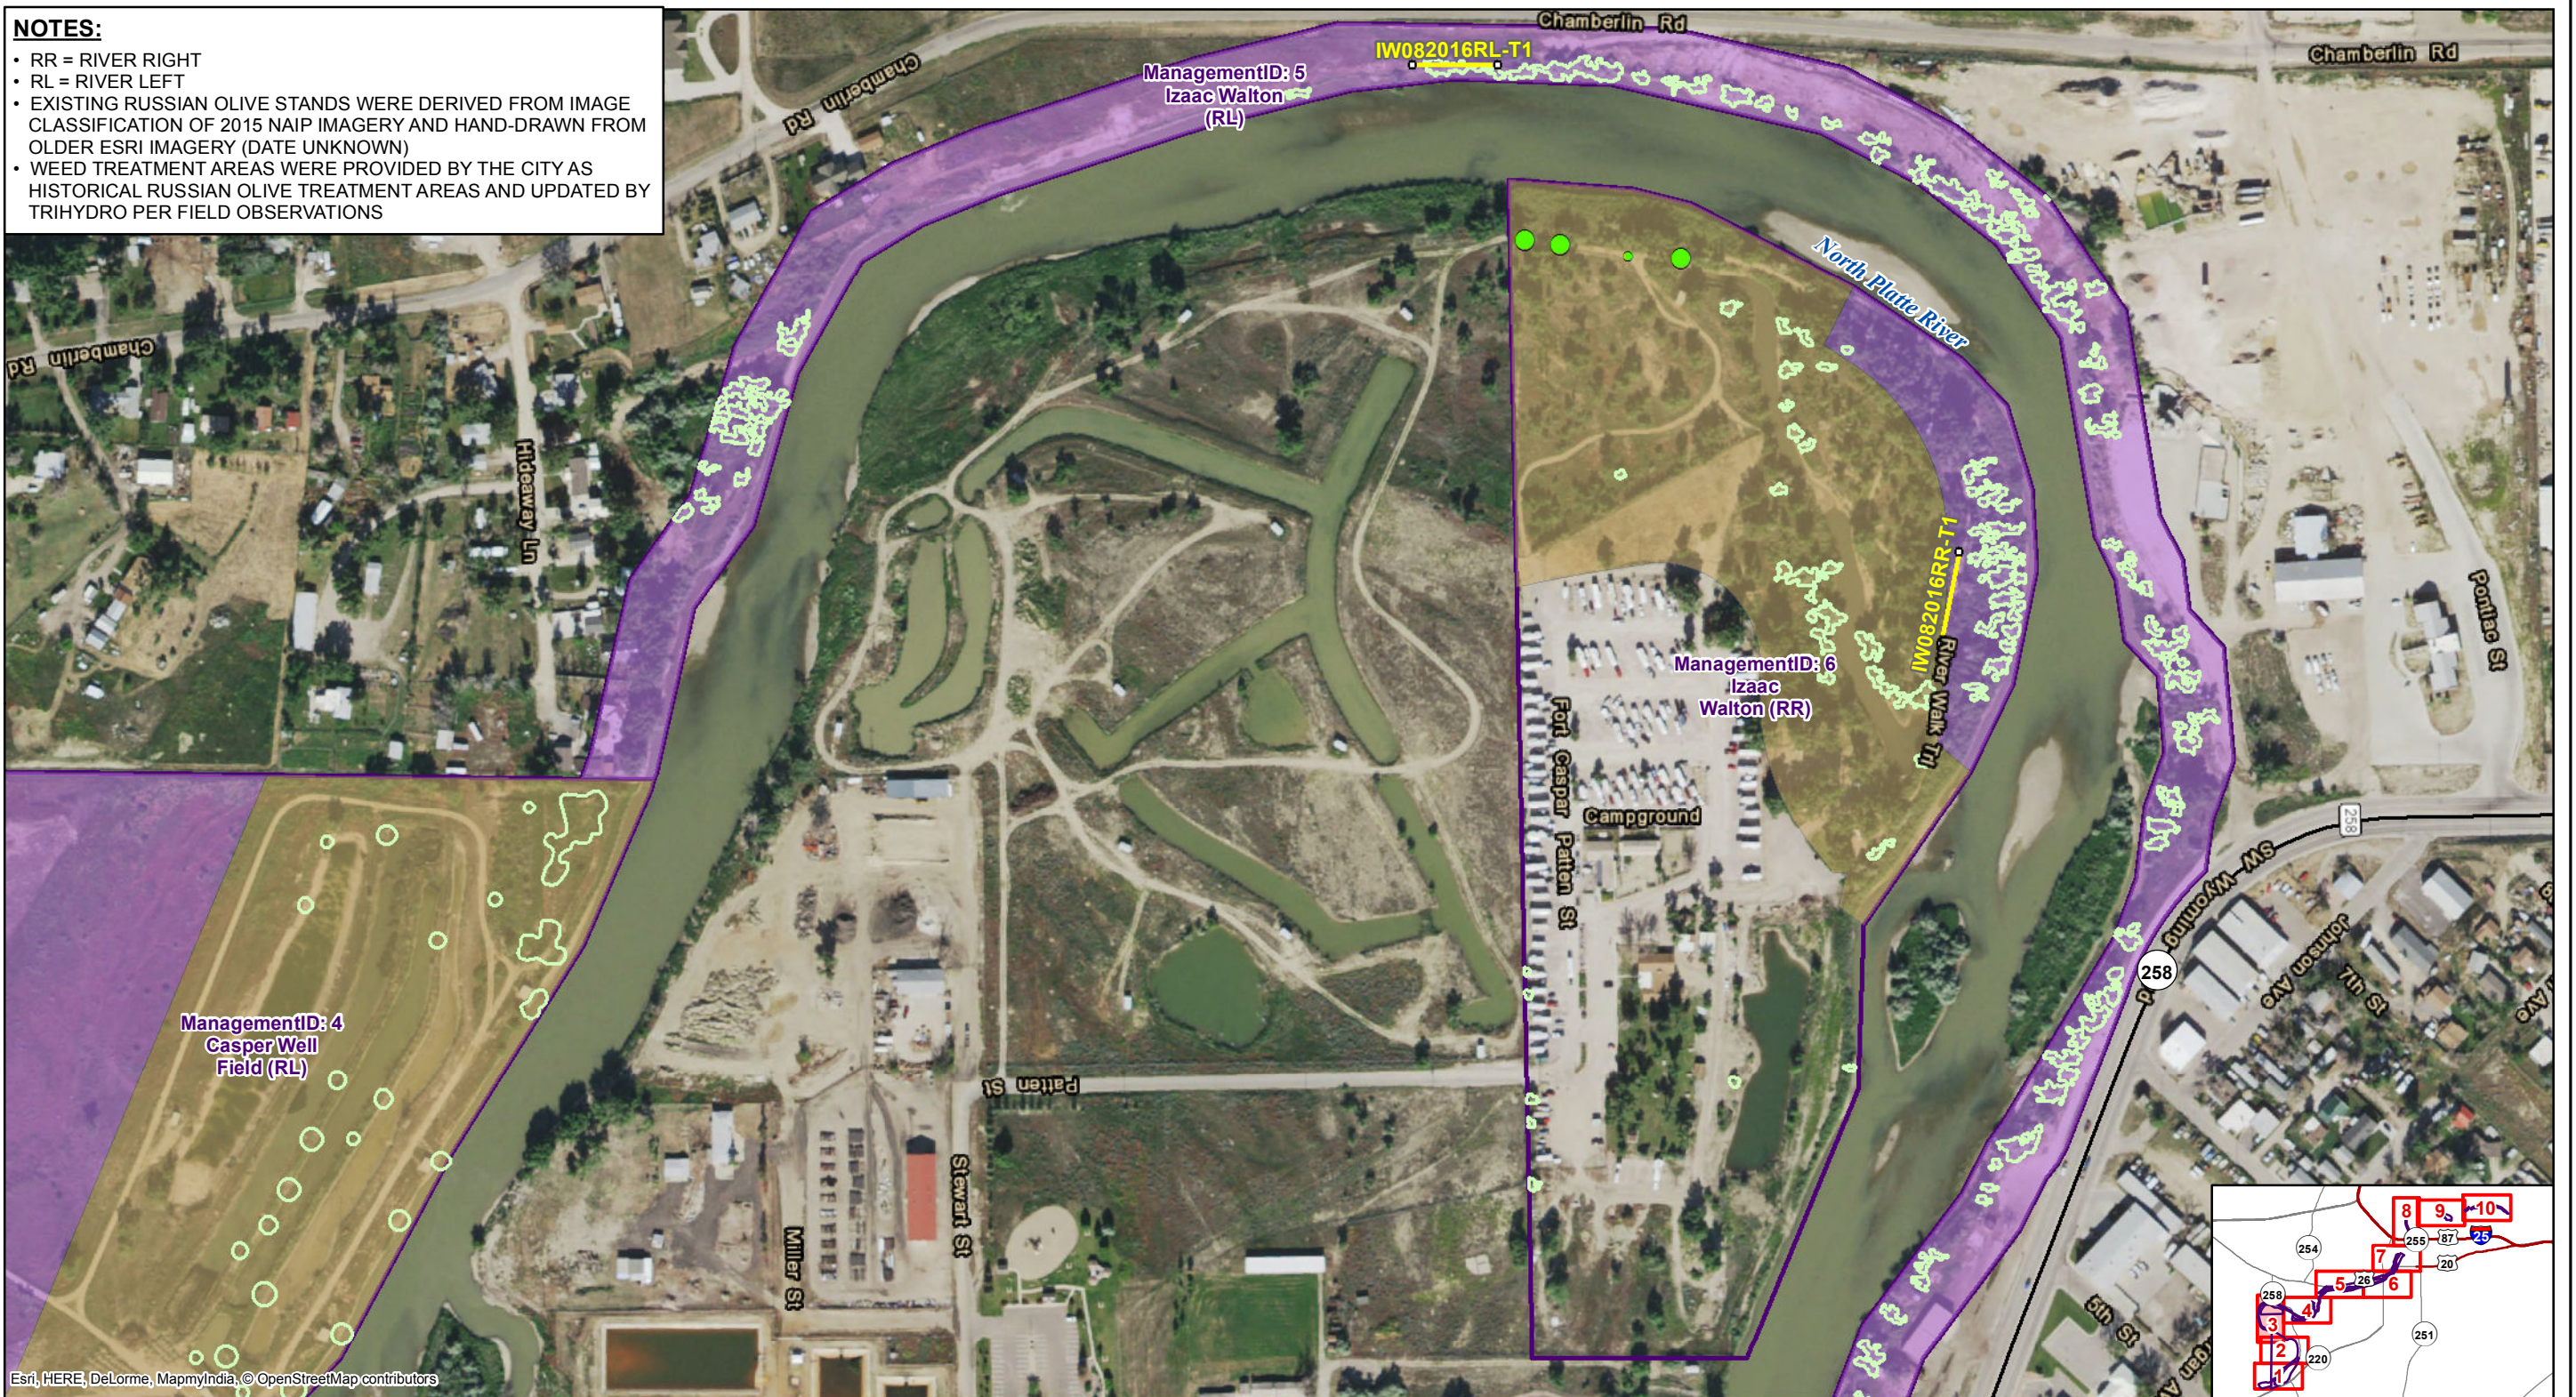
Reconnaissance revealed that large, mature Russian olives have established within the WMA (Figure 3). The recommendations for this WMA are to mechanically remove the large trees as feasible, in conjunction with cutting trees and applying herbicide to stumps. Follow-up monitoring is also recommended to identify any resprouts or regrowth, which can be retreated with cutting and herbicide application. Access to this area is mixed, as the flat areas next to the road quickly gives way to steep river banks.

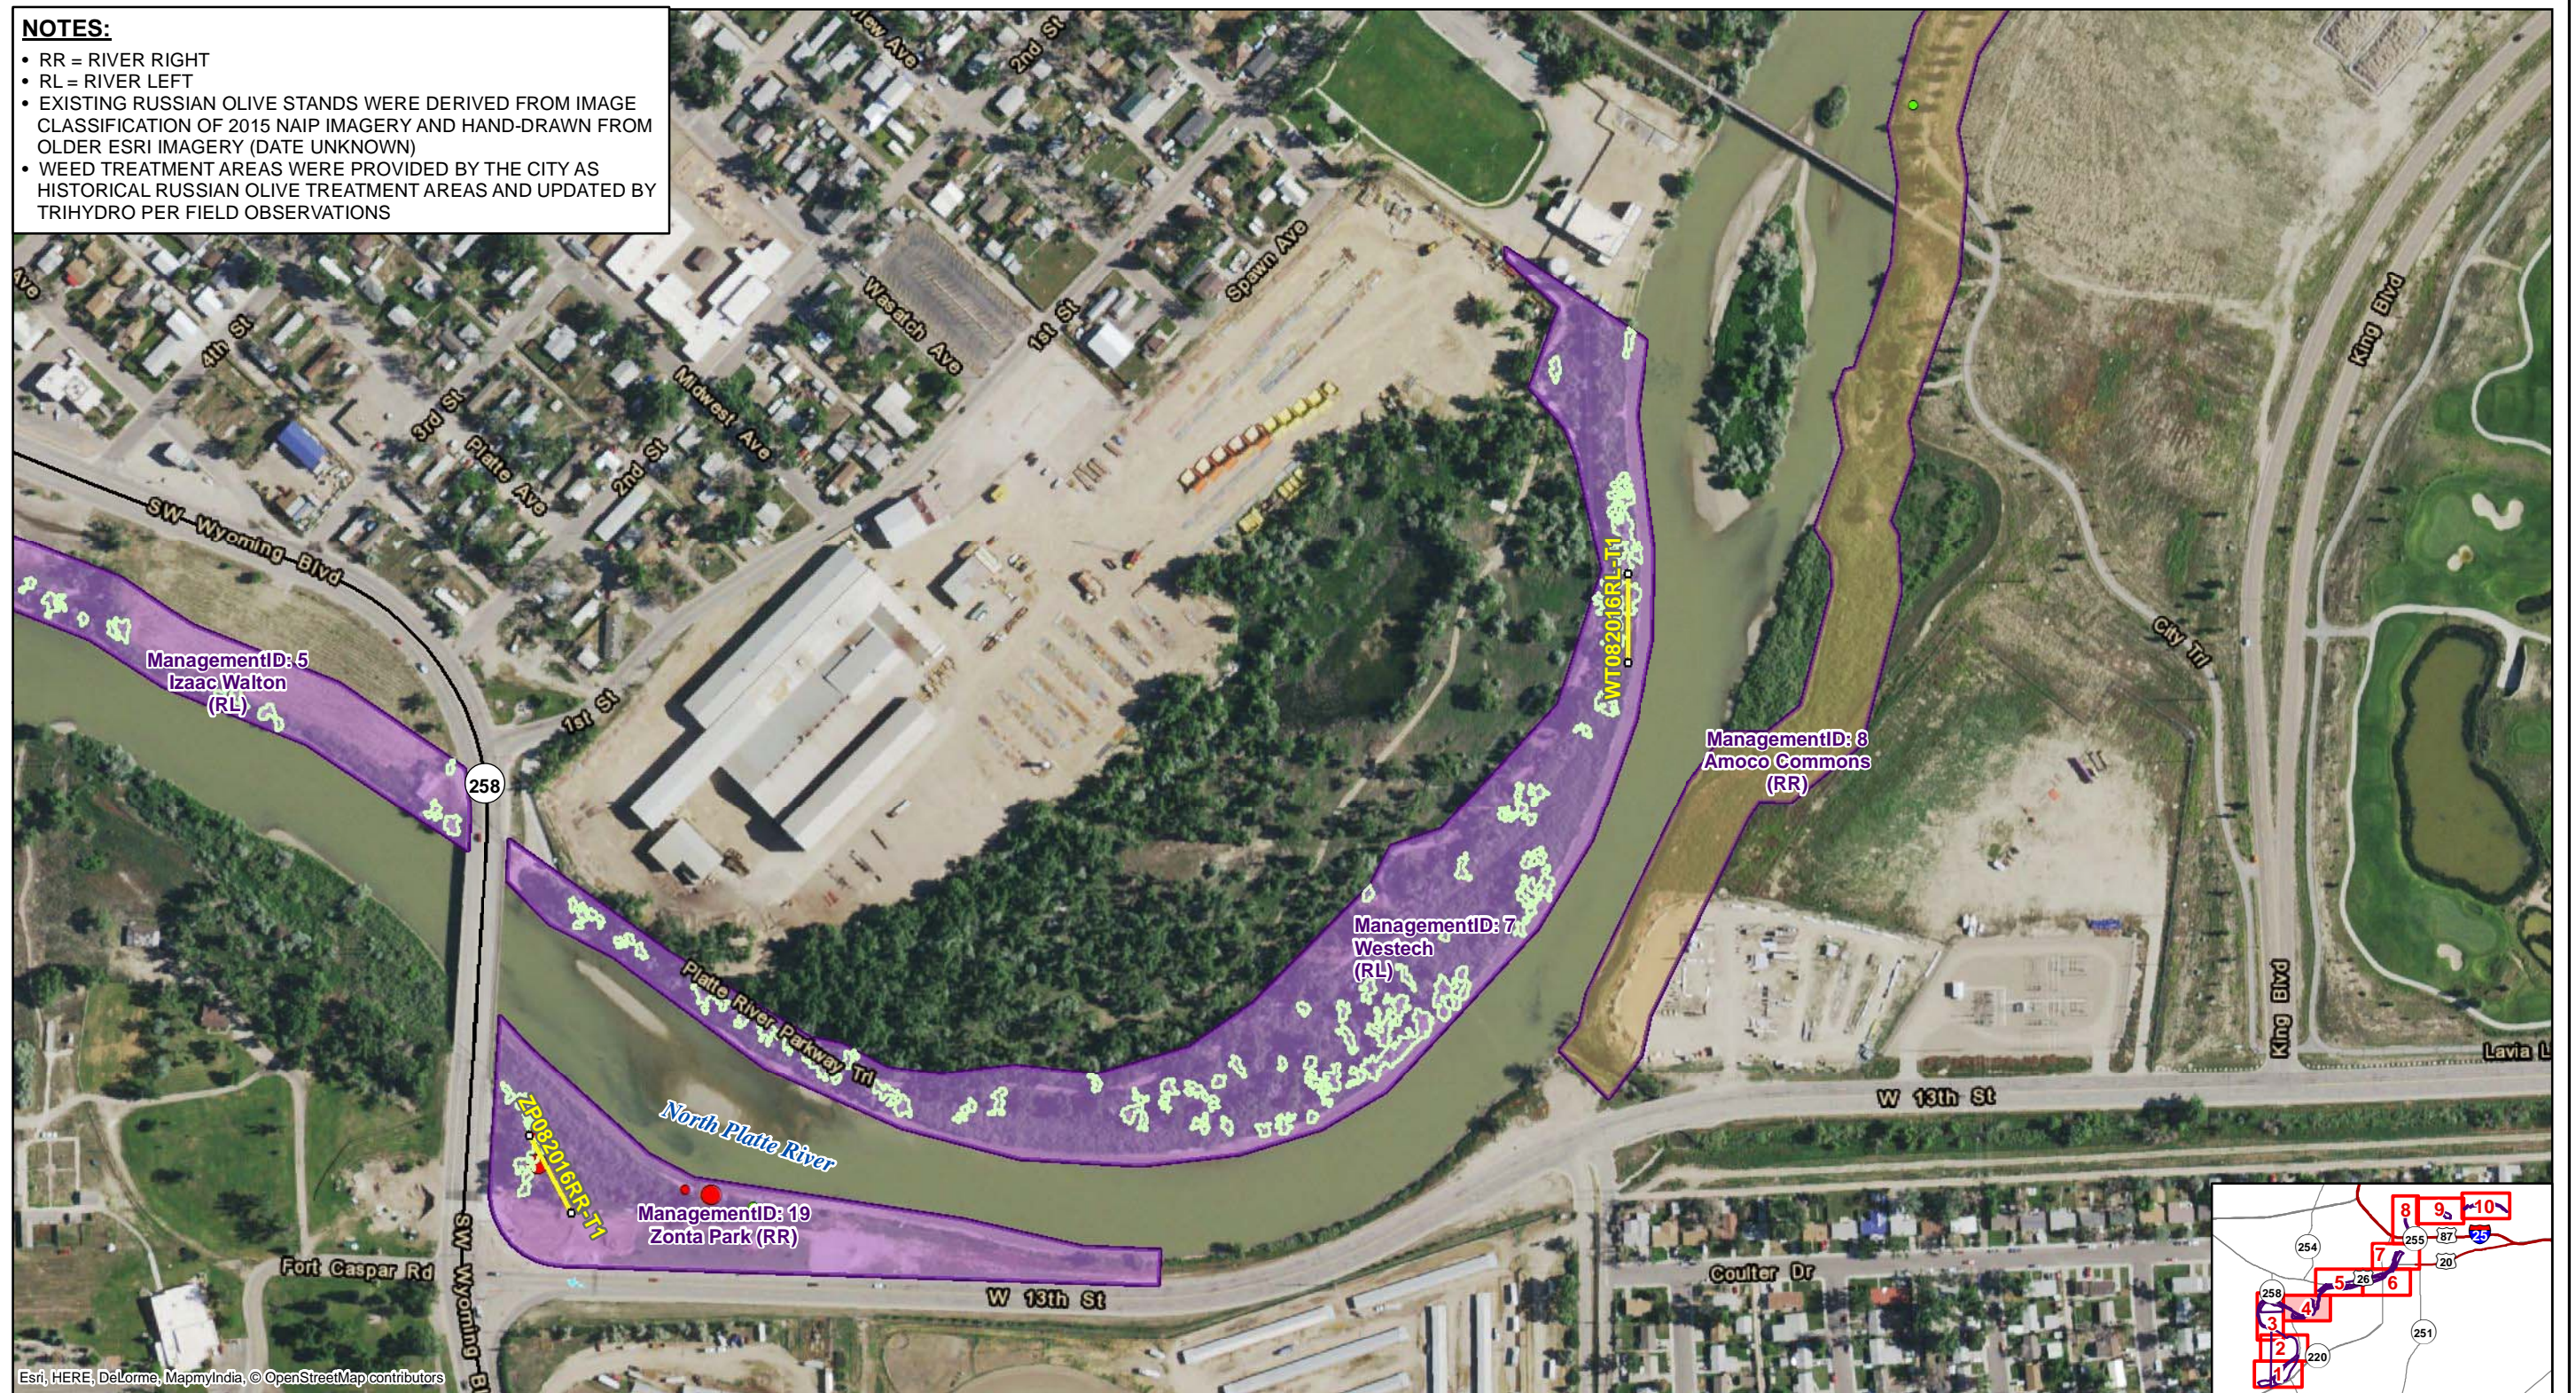
Reconnaissance revealed that thick stands of mature Russian olive are present throughout the area (Figure 4). Accessibility is limited in this area; therefore, cutting and spraying is recommended. Monitoring the effects of the treatment to quantify and treat regrowth is also recommended.

Reconnaissance revealed that there was very little regrowth, and the existing regrowth had been flagged with high-visibility tape (Figure 4). The river bank itself is comprised of riprap, and overall, the area contains mostly native species. The recommendation for this WMA is to treat regrowth and continue to monitor the river bank. While

accessibility to this area is easy with equipment, cutting and spraying are recommended for the near term due to limited regrowth. Limited cover by cheatgrass was observed during the vegetation survey.

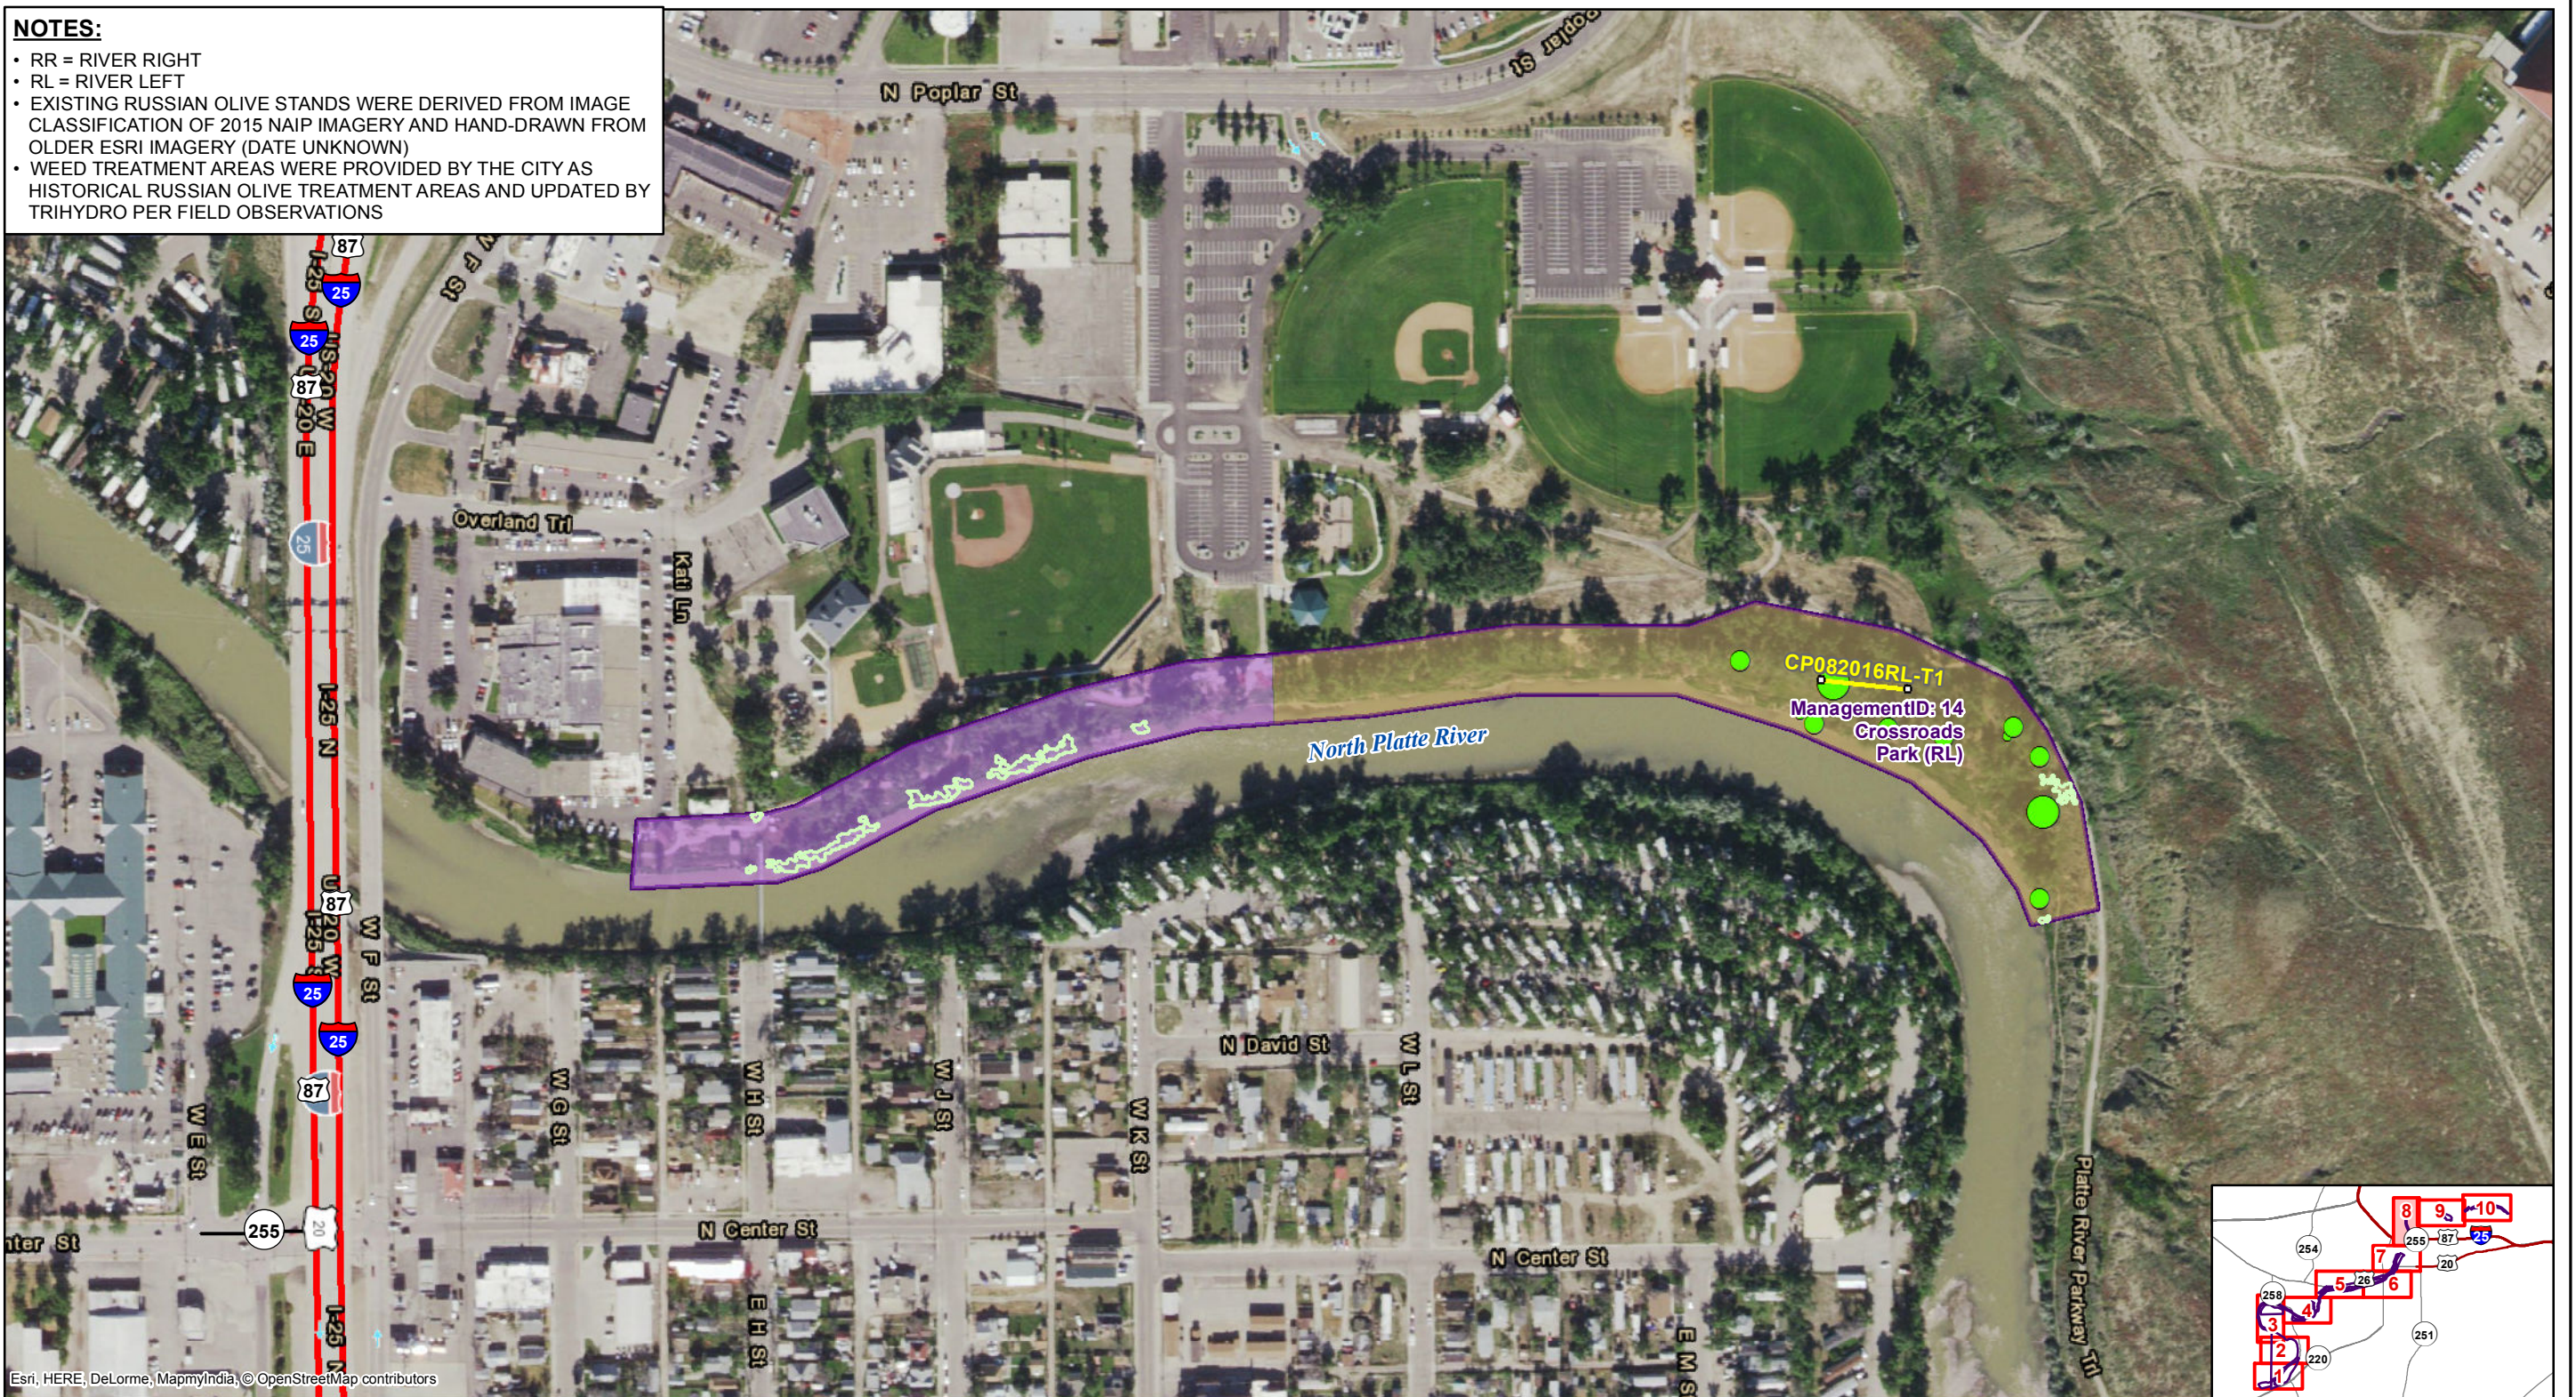
Reconnaissance revealed that there is substantial regrowth in some of the treated areas and significant untreated growth immediately south of the management area (Figure 8). The grove of regrowth in the northern end of the treatment area is currently being pruned to allow pedestrian access to a walking/biking trail. Recommendations include cut-stump treatment and spraying of regrowth, as well as monitoring the growth south of the management area to ensure that recruitment does not occur. Accessibility with equipment is moderate, and a network of single-track, dirt trails is present.

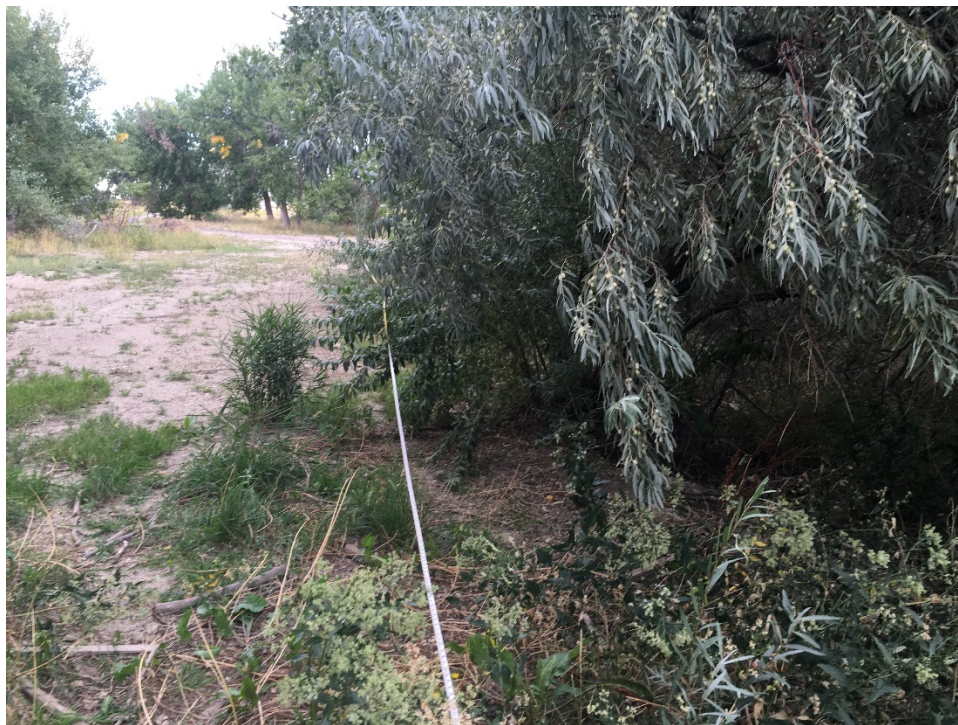
Management ID: 18 (WT082016RR)

Specific follow-up treatment recommendations have been provided within this report to assist the City with their future Russian olive management efforts. A critical component of this restoration project in the future is baseline data collection and post-treatment monitoring to quantify treatment success and determine the nature and extent of follow-up treatments to treat regrowth. Trihydro understands that the City’s invasive species management has focused on Russian olive with some attention given to cheatgrass. In several locations, cheatgrass cover was determined to be greater than 15% and monitoring of cheatgrass in these areas is recommended so that a management plan can be implemented if cheatgrass cover continues to increase. In WMA 18, which is an untreated WMA, tamarisk was

observed. Tamarisk can spread quickly in riparian areas and is considered a noxious weed in the state of Wyoming. Given that tamarisk is currently localized in its distribution along the North Platte River, a plan to treat this species in the near future might be effective in eliminating it and minimizing further spread to other WMAs.
