2016 Annual Monitoring Report for the North Platte River Restoration Project

Mike Robertson, Instream Flow Biologist, Wyoming Game and Fish Department, 5400 Bishop Blvd, Cheyenne, WY 82006

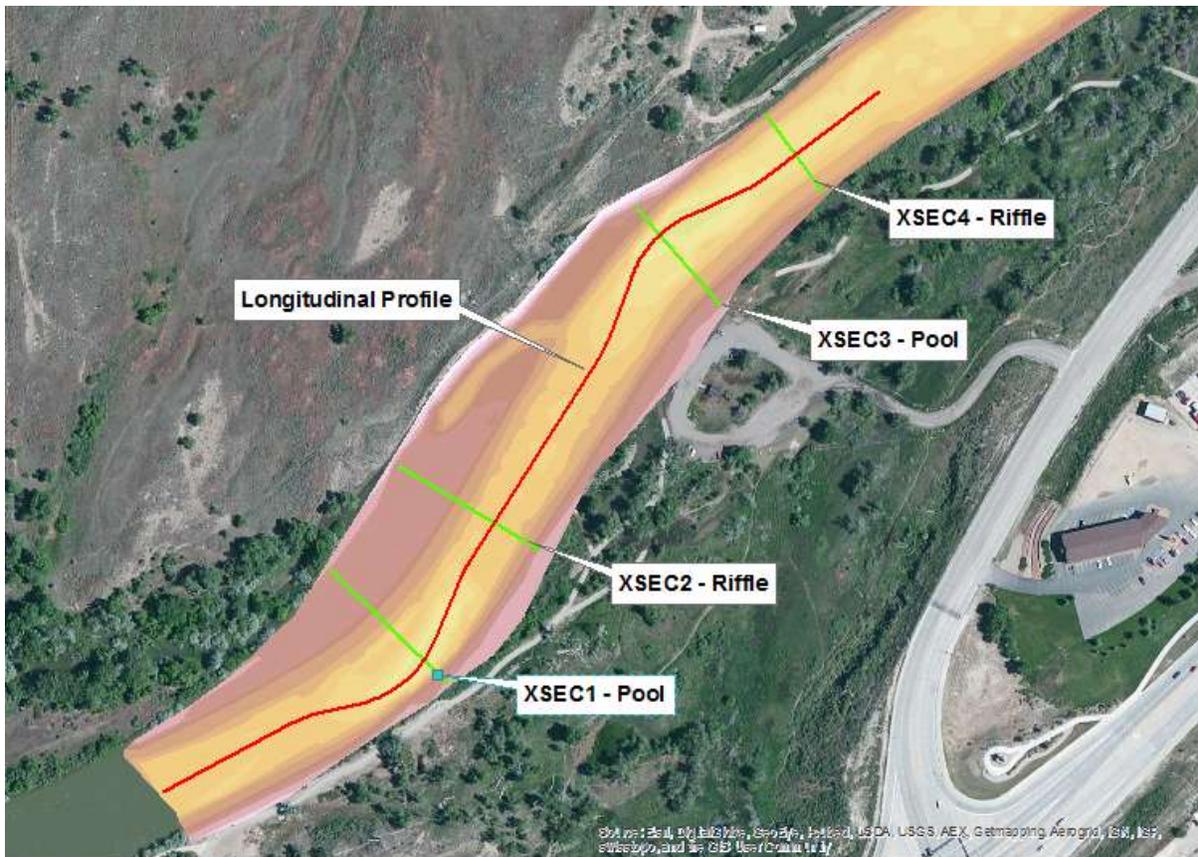
FIGURE 1 – Morad Park project site including the longitudinal profile, which delineates the project reach and cross-sections including: two pools and two riffles.

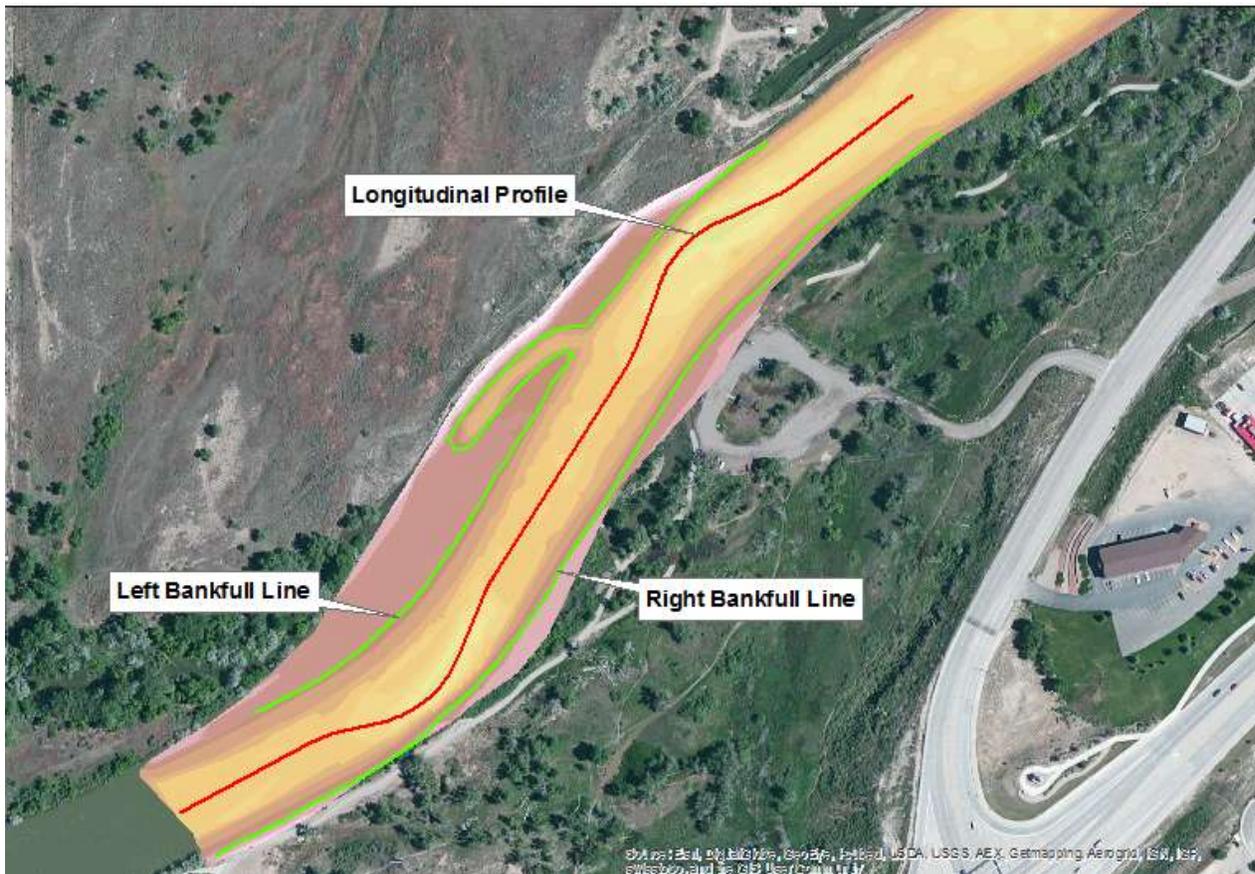
Both sides of the river were surveyed to create a continuous bankfull line for each bank on November 2, 2016 when discharge was approximately 485 cfs (Figure 2).

Figure 2. Map displaying the longitudinal profile line (thalweg) and left and right bankfull lines. The location of each of these lines may be compared annual to determine whether any lateral migration occurs.

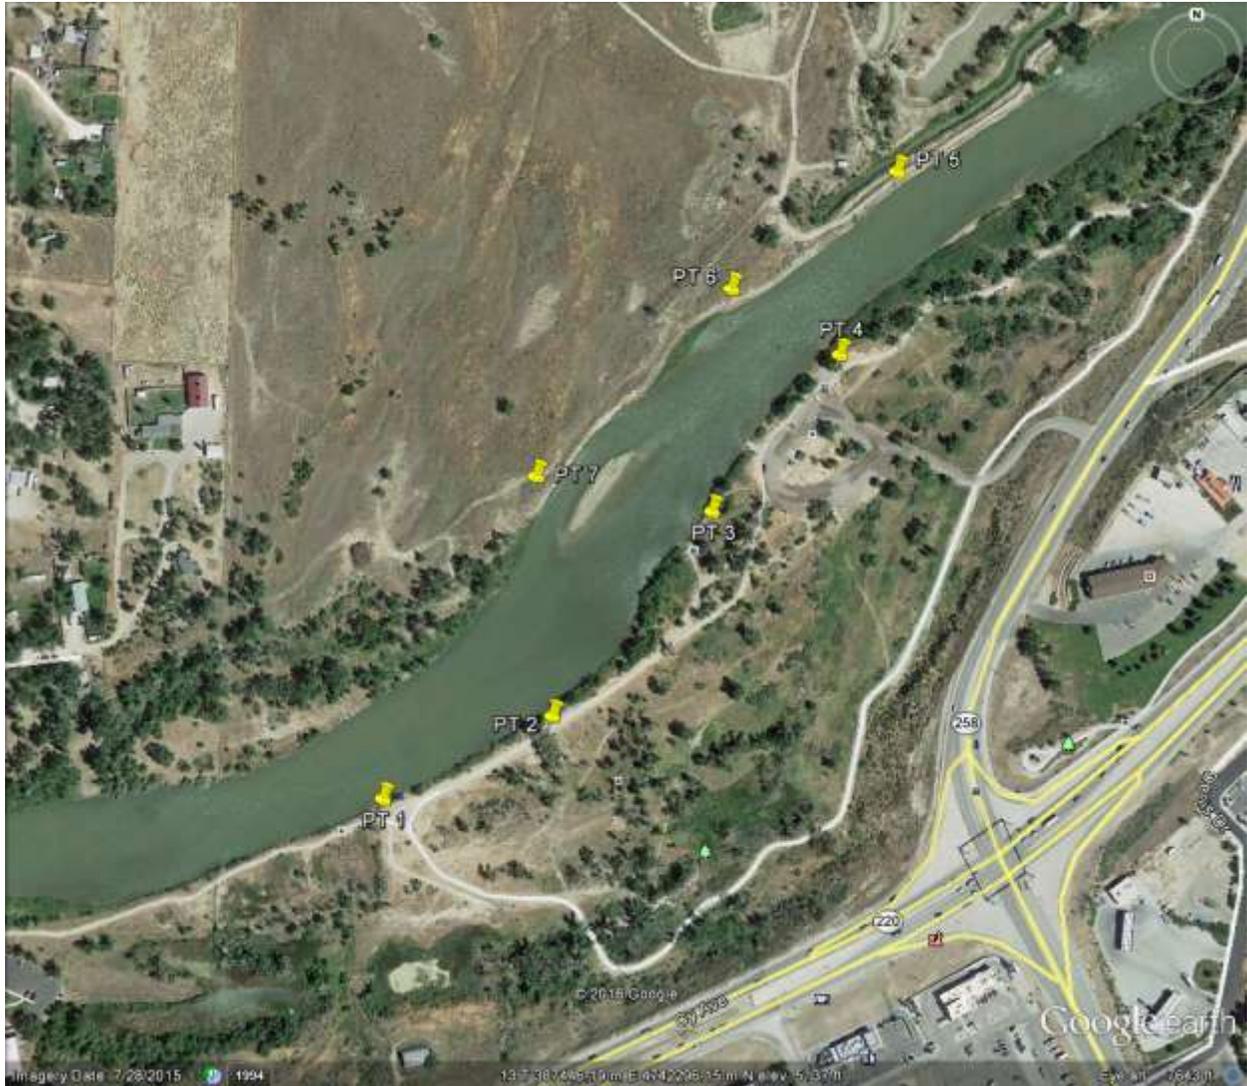
Figure A1. Approximate location of seven photo monitoring points on Site 1- Morad Park. Note that the imagery from Google Earth to display these locations was taken prior to construction efforts associated with the restoration project.

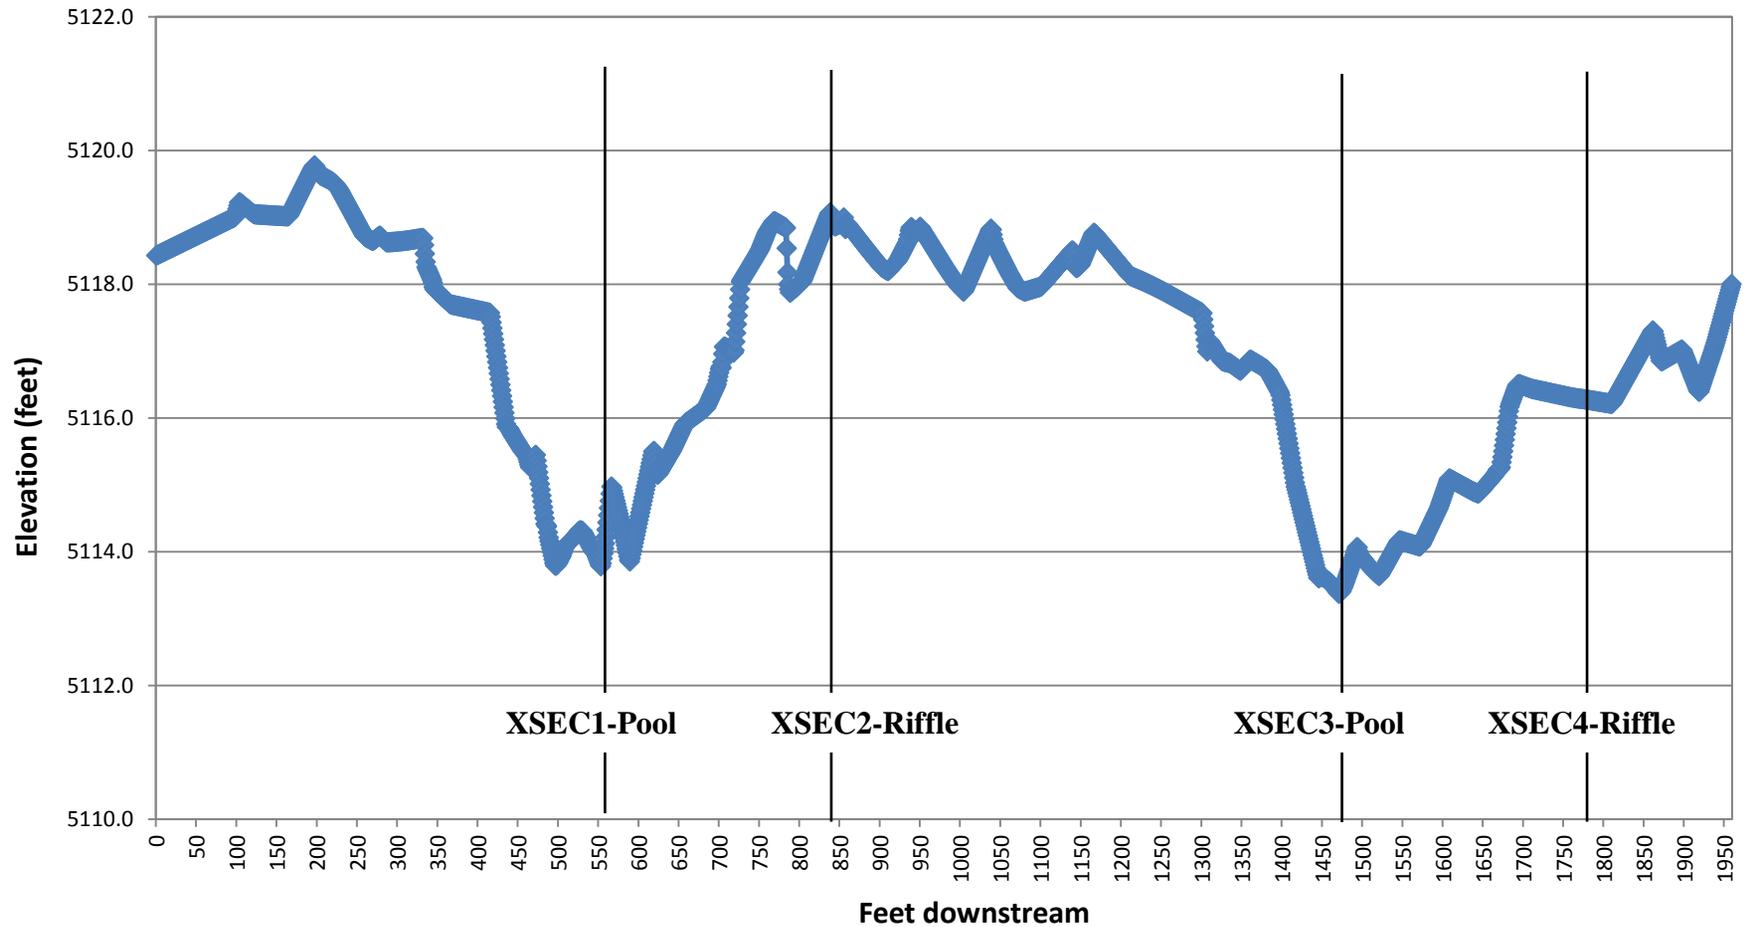
Figure B1. Longitudinal profile of Site 1 – Morad Park collected in October 2016. The approximate location of each cross-section (XSEC) is noted.
